June 2023

Greensboro Aquatic Facilities Master Plan

Greensboro, North Carolina

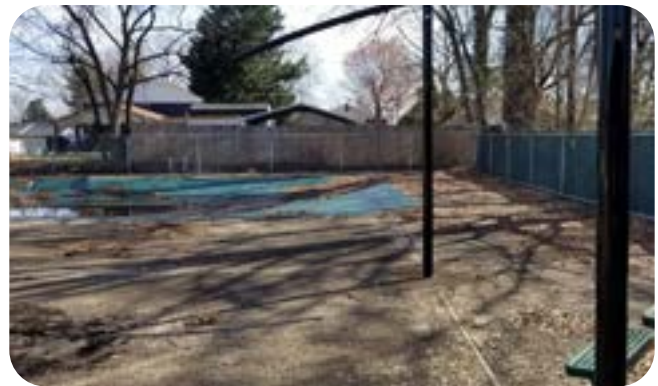
Deck covered in leaves and a deteriorating pool cover

In general, the park is well-kept. The pool area does not appear to have seen any maintenance in recent years, evident by a large collection of leaves on the deck and pool cover via surrounding trees. Vegetation consisting of cattail and willow saplings has started growing on the pool cover. The ball courts have been recently resurfaced with the basketball court having futsal equipment added as part of a master plan phased construction project.

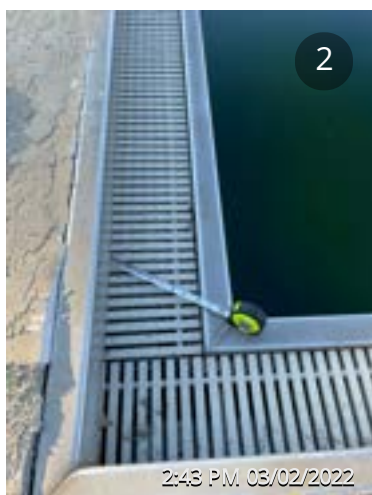
DEPTH MARKERS AND NO DIVING MARKERS

Depth markers and no diving signs were a combination of tiles and paint. Depth markings were noted on the vertical surfaces attached to the fence.

NC Code .2523, .2537

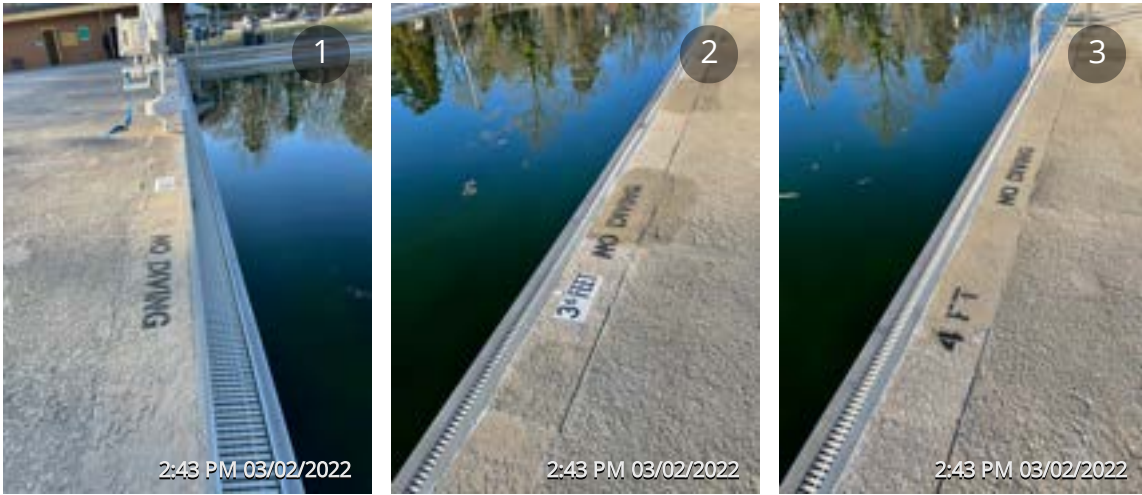
DEPTH MARKERS AND NO DIVING MARKERS (CONTINUED)

Depth markers and no diving signs were a combination of tiles and paint. Depth markings were noted on the vertical surfaces attached to the fence.

NC Code .2523, .2537

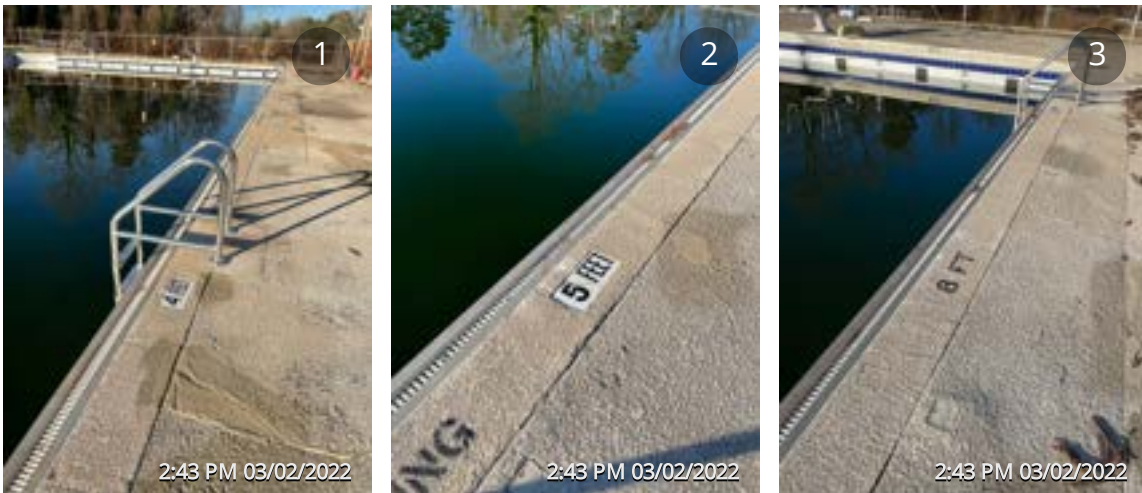
DEPTH MARKERS AND NO DIVING SIGNS (CONTINUED)

Depth markers and no diving signs were a combination of tiles and paint. Depth markings were noted on the vertical surfaces attached to the fence.

NC Code .2523, .2537

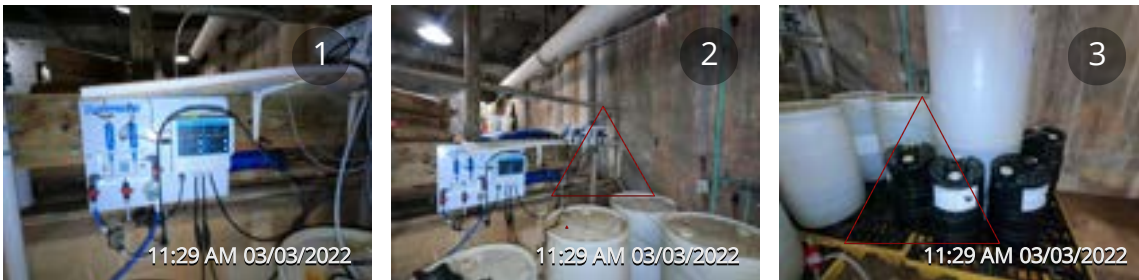
LAP POOL EQUIPMENT ROOM - FILTRATION SYSTEMS

The pool uses two 96" High Rate Sand Filters. The data plates were nearly unreadable but indicate a date of manufacturer of 1985.

These filters have a life expectancy of 20-25 years

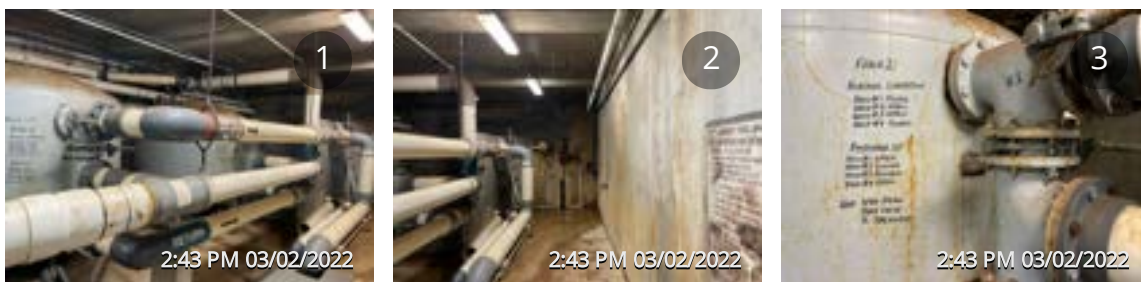
LAP POOL EQUIPMENT ROOM - FILTRATION SYSTEMS (CONTINUED)

The pool uses two 96" High Rate Sand Filters. The data plates were nearly unreadable but indicate a date of manufacturer of 1985. These filters have an estimated life expectancy of 20-25 years.

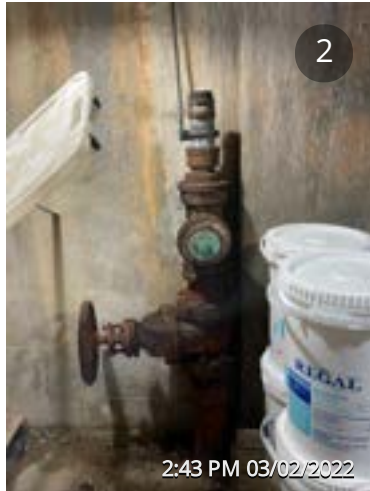
LAP POOL EQUIPMENT ROOM - DOMESTIC WATER FILL

Freshwater fill system. The operational condition is unknown.

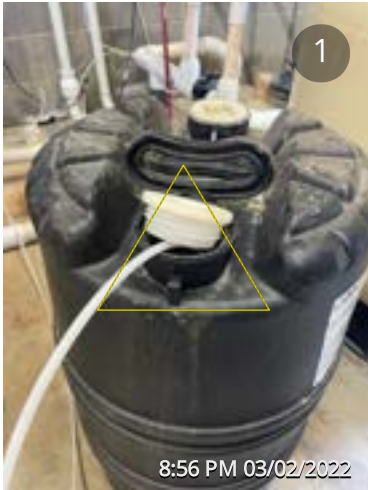
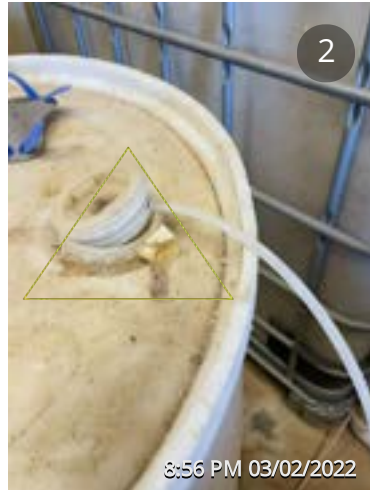
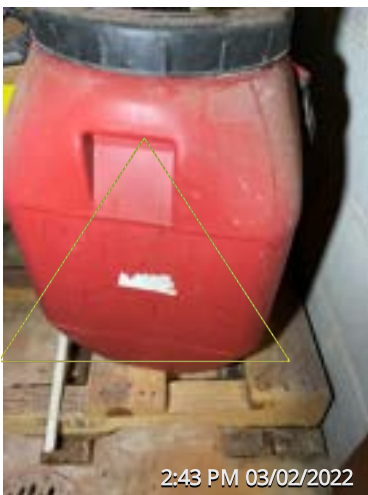
LAP POOL EQUIPMENT ROOM - SAFETY CONCERN

An empty cyanuric acid container was found in a chemical storage area that was hand-labeled "Cal Flake" CDC Chemical Safety Handling: Store chemicals in original, manufacturer's-labeled containers.

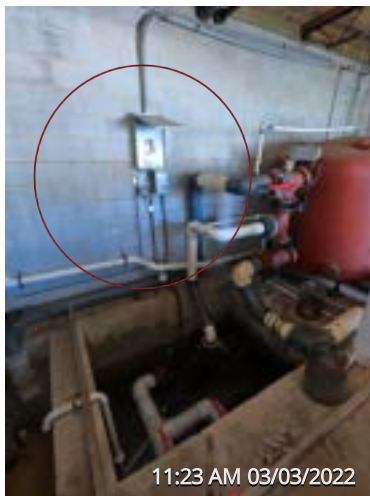
POOL EQUIPMENT ROOM - LAP POOL FILTRATION SYSTEM - SAFETY CONCERN

Safety Concern: The circuit breaker panel and pump electrical systems can only be accessed by straddling an open pump pit.

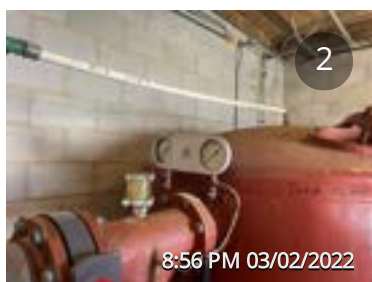
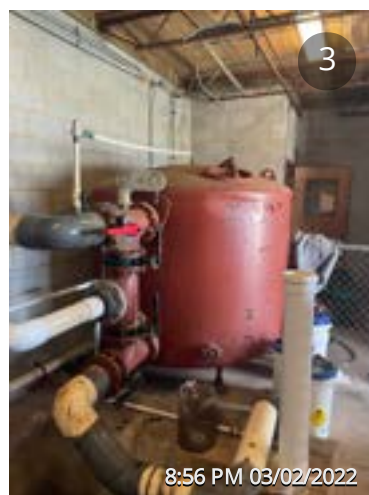
CHILDREN'S POOL - CIRCULATION SYSTEM

The pool uses a single sand filter with a multiport valve with a 1.0hp pump

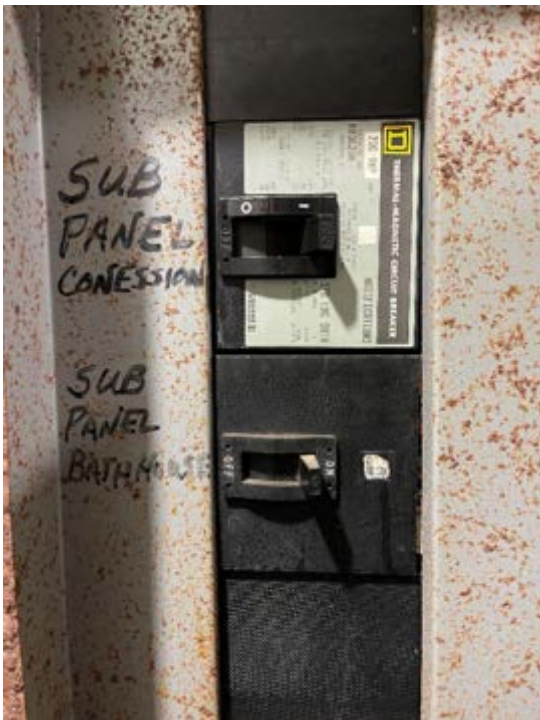
Figure E12 - Surface Rusting

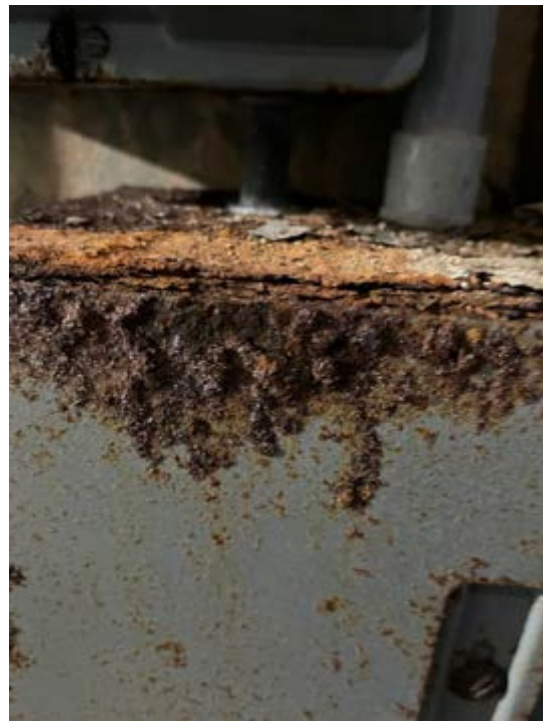
Figure E13 - Panel Degradation

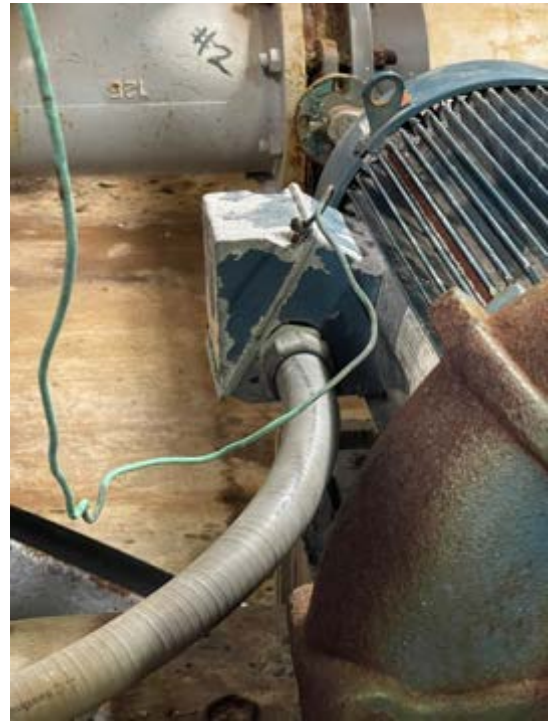
Figure E15 – Corrosion at Pool Pump Bonding Lug

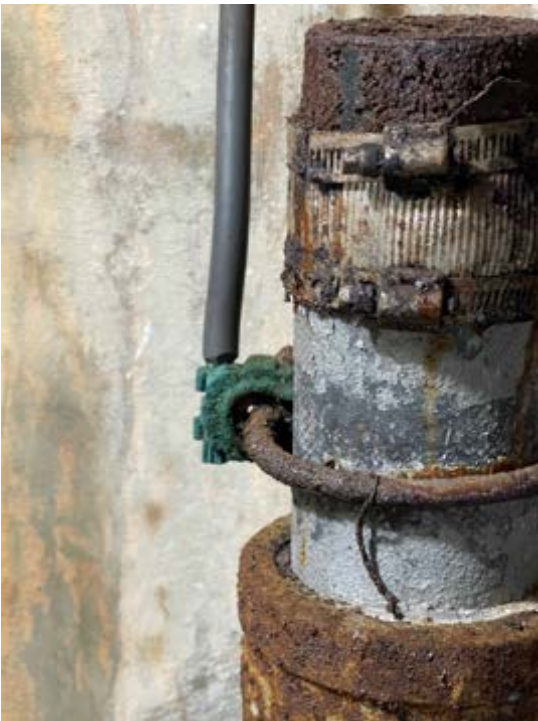
Figure E16 - Bonding Means Incorrect and Corroded

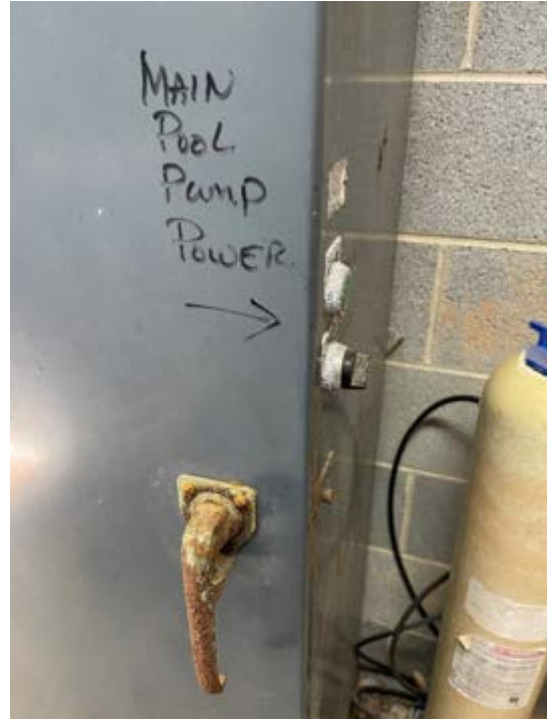
Figure E24 – Cabinet Corrosion
