MATRIX

Health & Safety Consultants, L.L.C.

March 20, 2023

Subject: Survey to Identify Asbestos-Containing Materials
Raymond S. King Apartments
1004 John Dimrey Drive
Greensboro, North Carolina 27406
Matrix Job Number: 210750

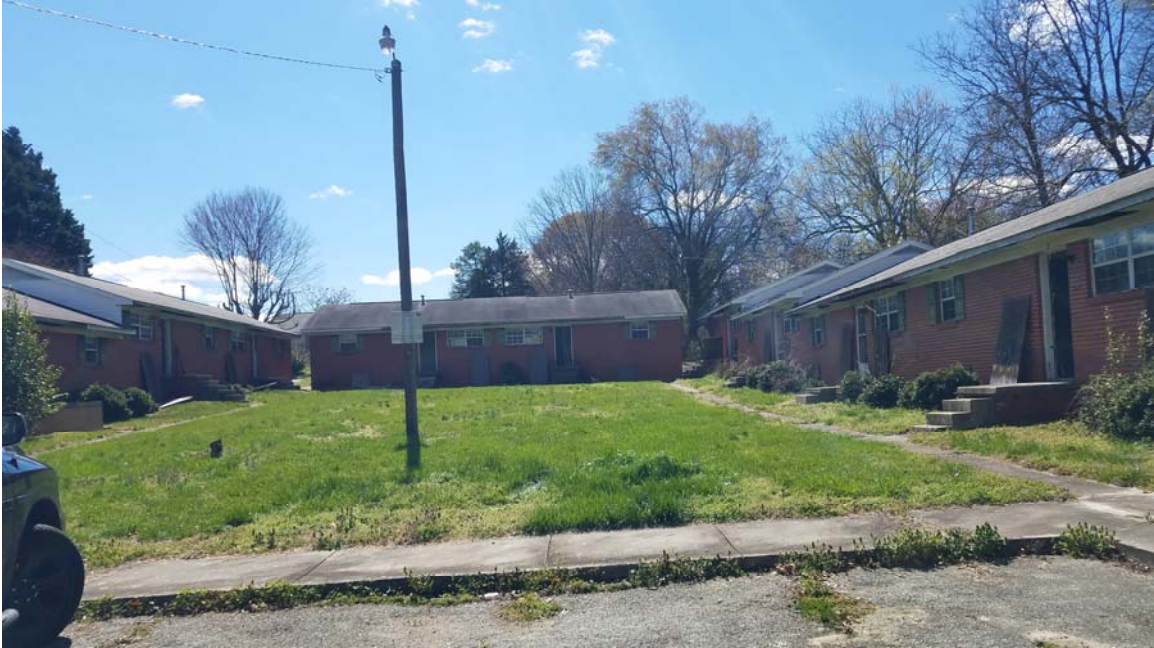
Example of roof shingles and felt.

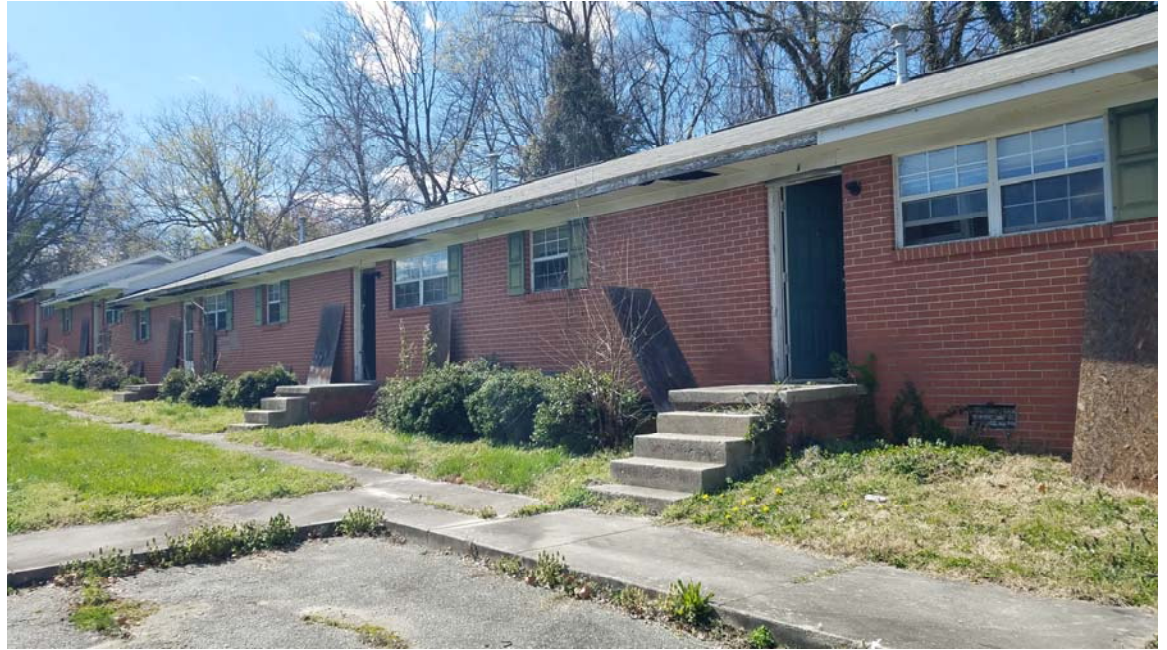
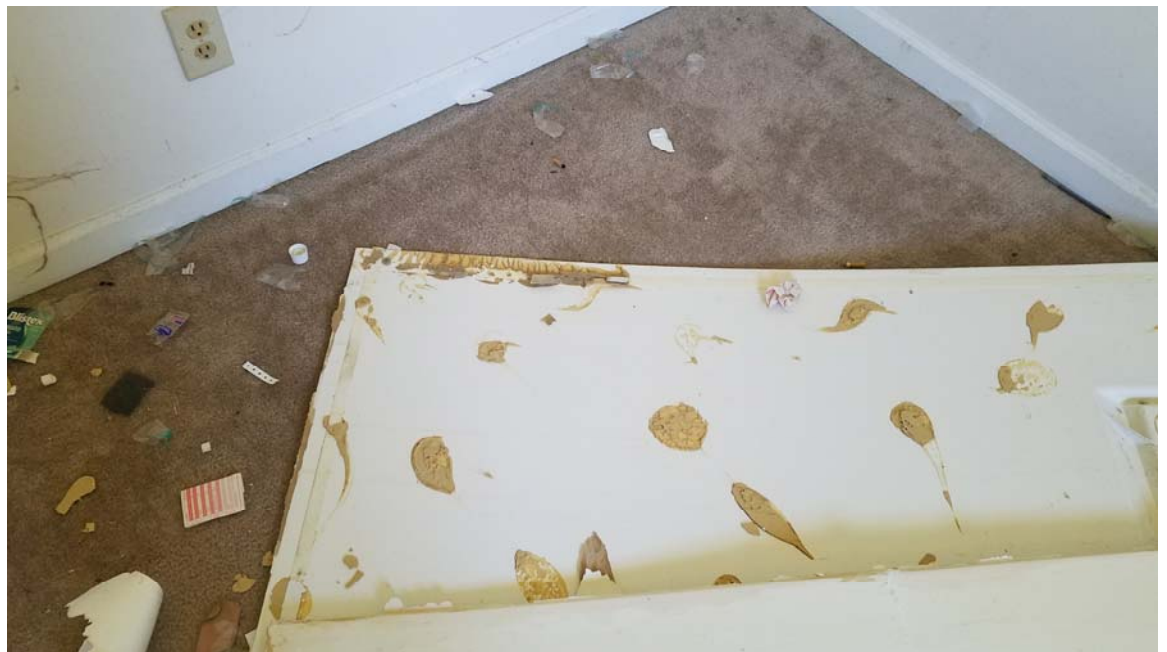
Example of wall glue and drywall/patch throughout each unit.

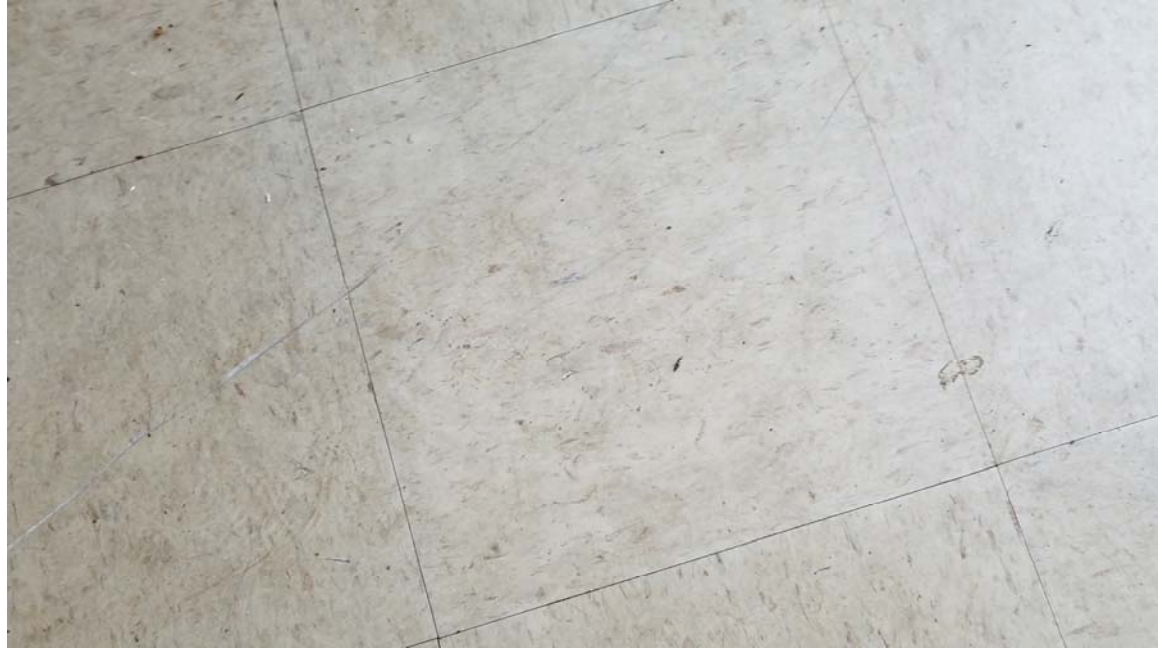
Example of flooring throughout each unit.

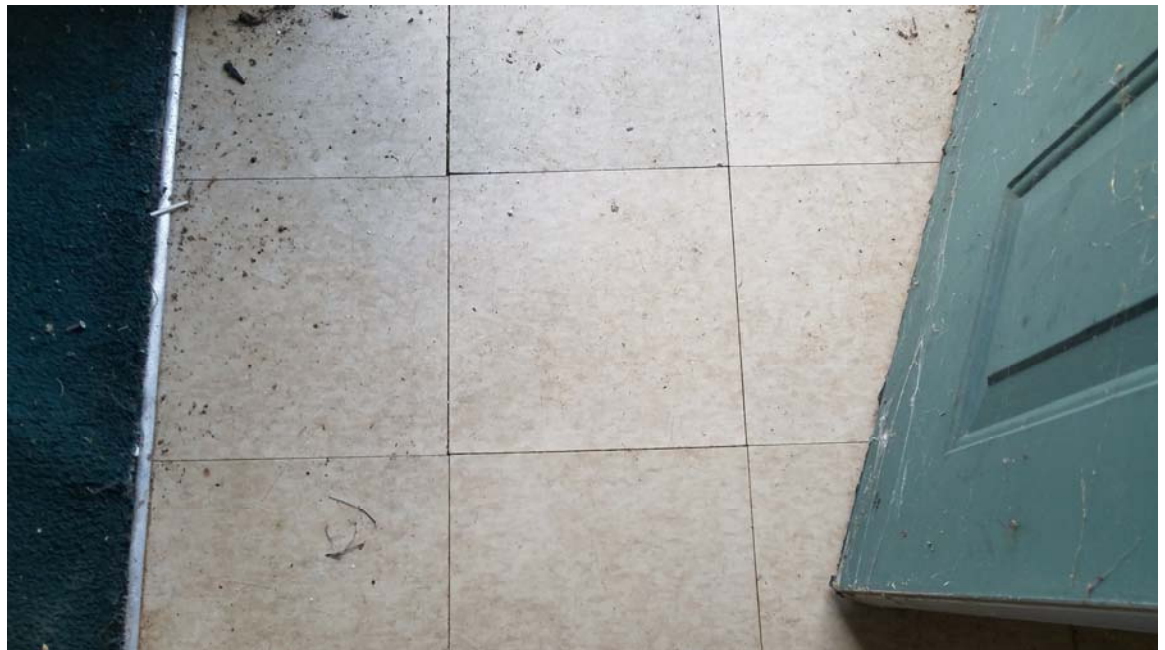
Example of flooring throughout each unit.

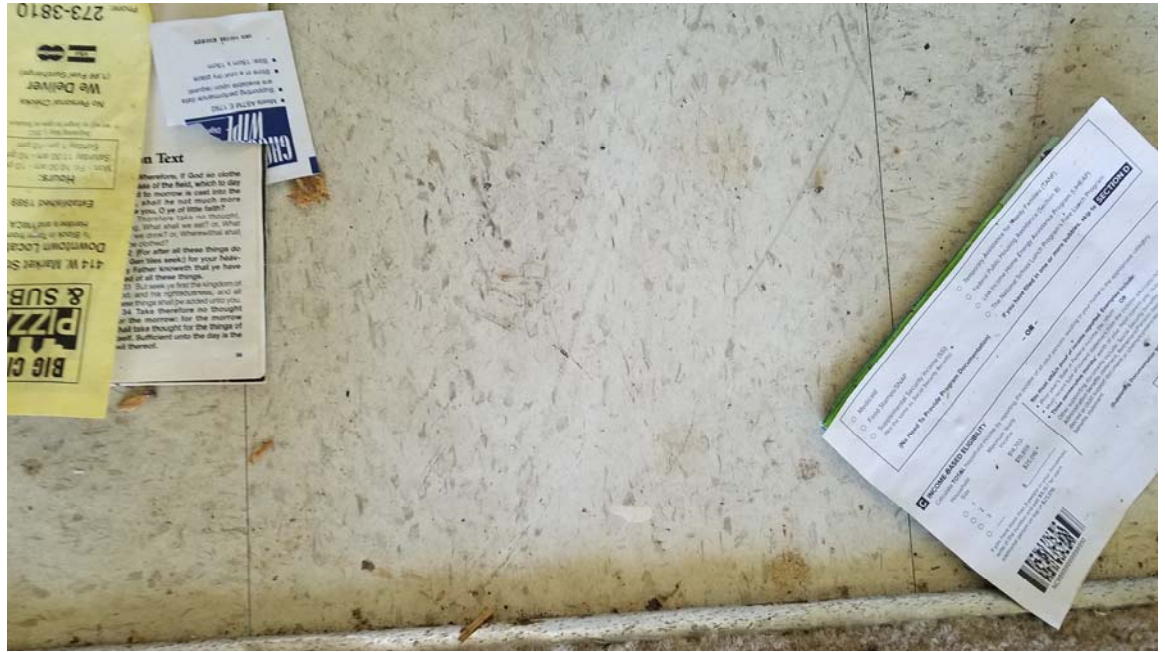
Example of flooring throughout each unit.

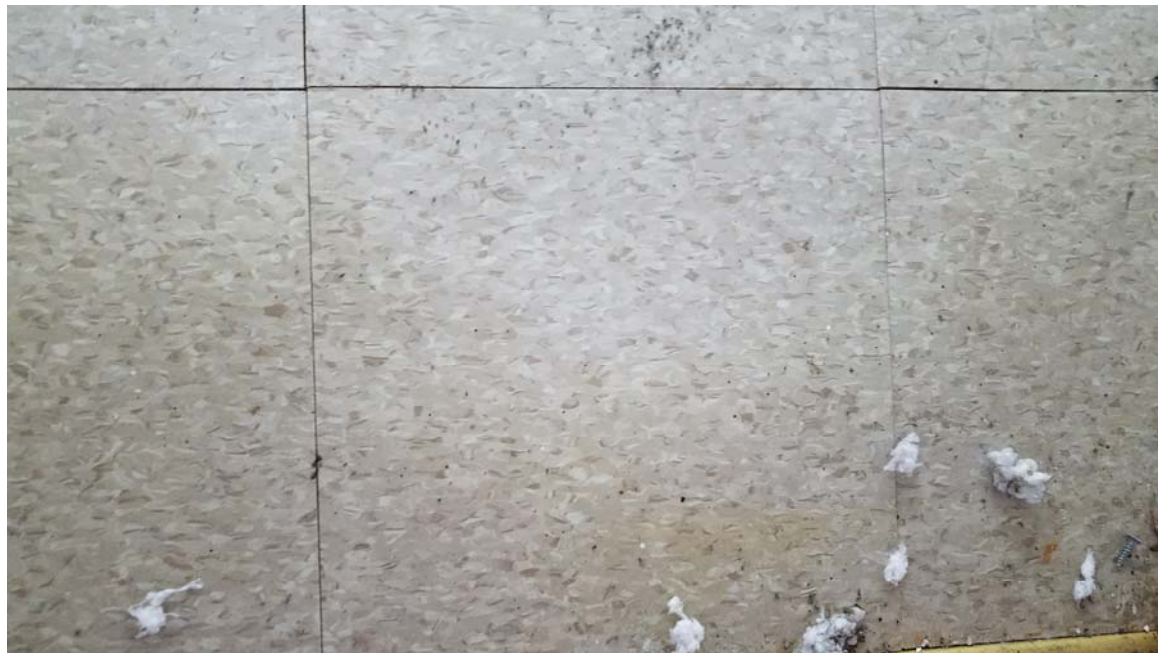
Example of flooring throughout each unit.

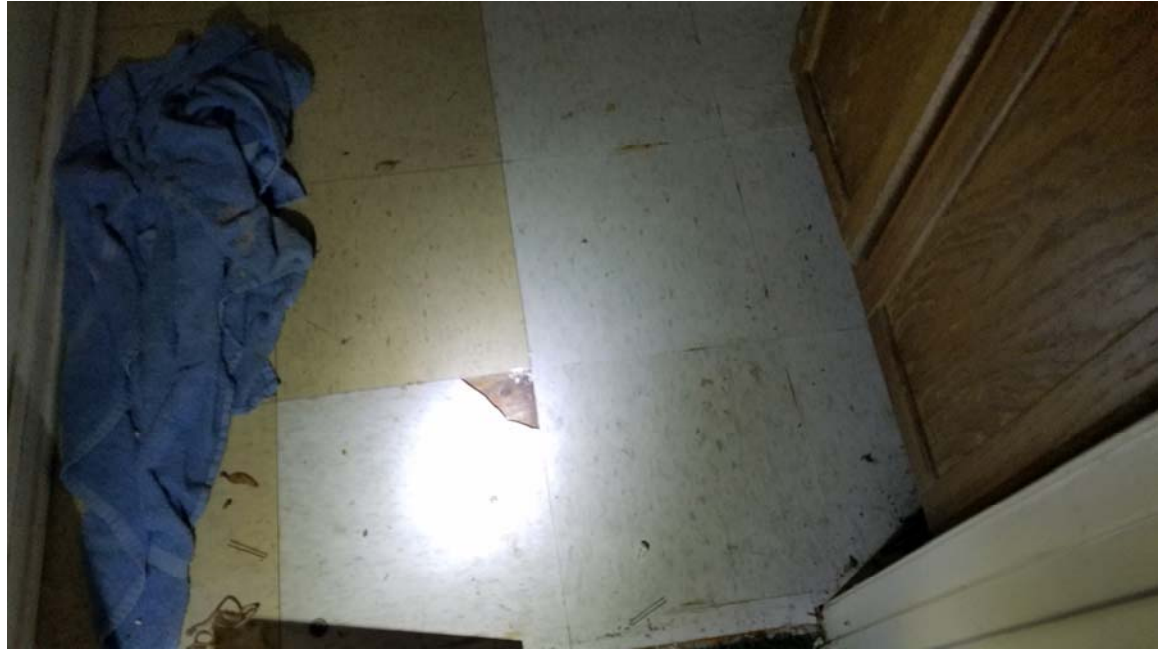
Example of flooring throughout each unit.

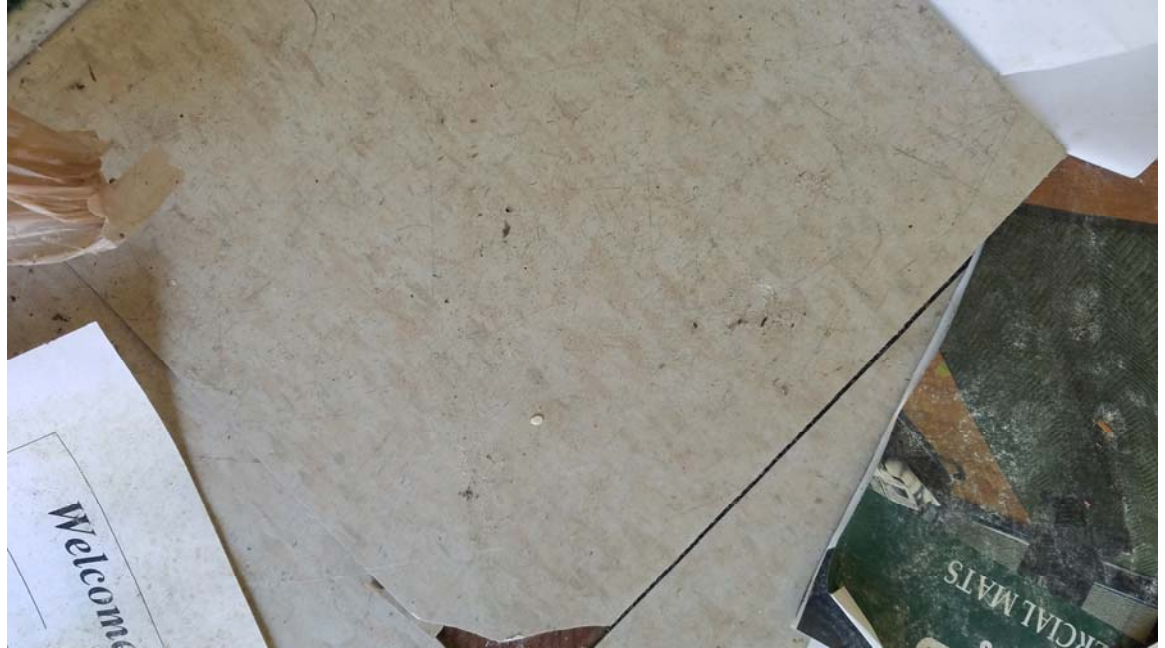
Example of flooring throughout each unit.

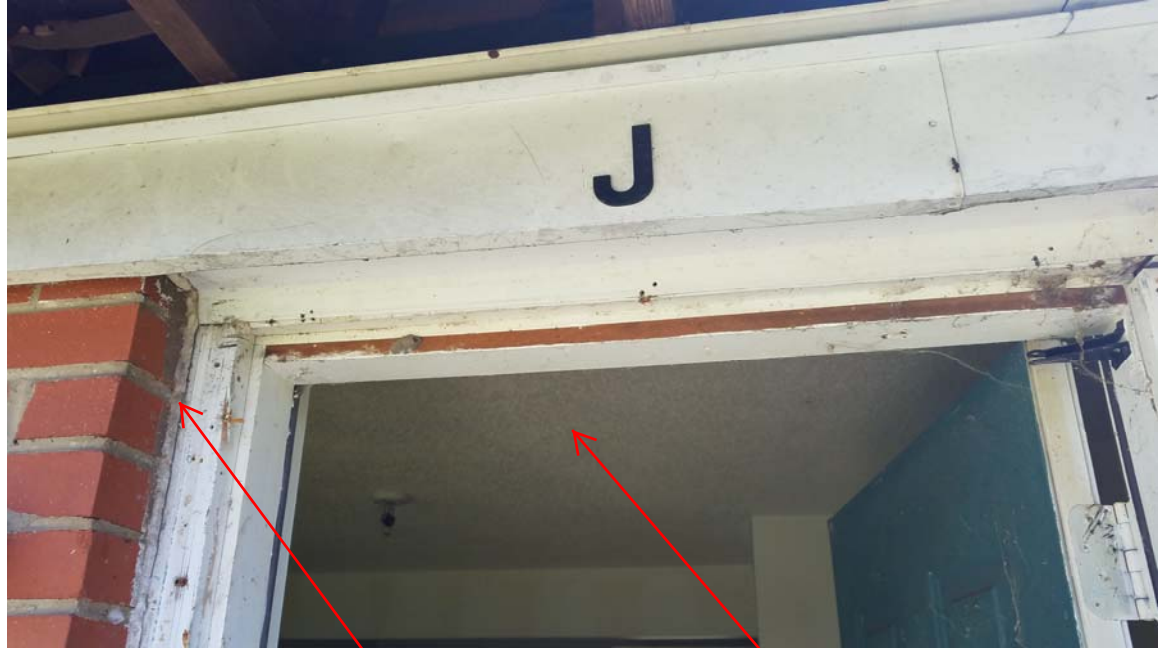
Example of exterior caulking and interior ceiling texture.

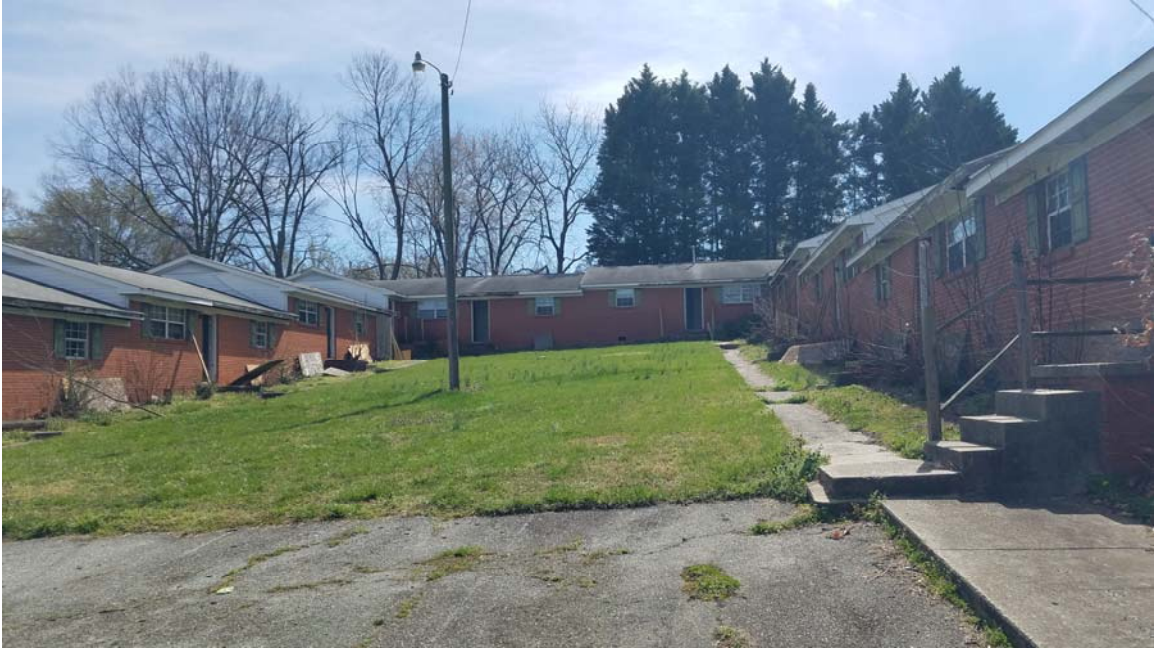
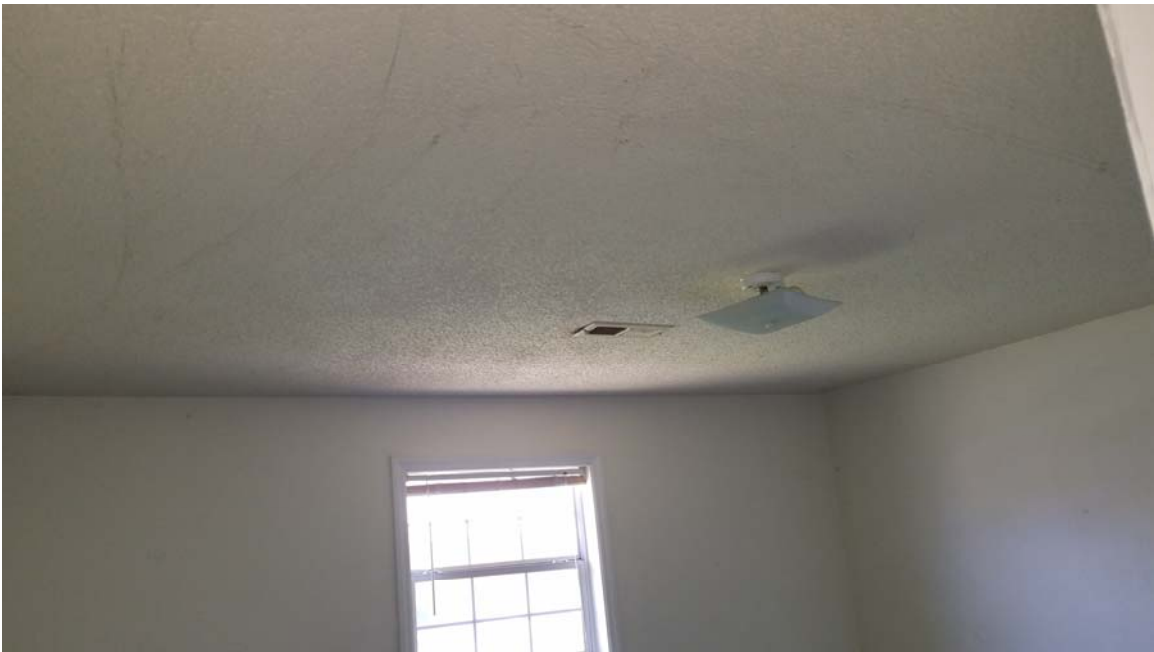
Example of ceiling texture throughout each unit.

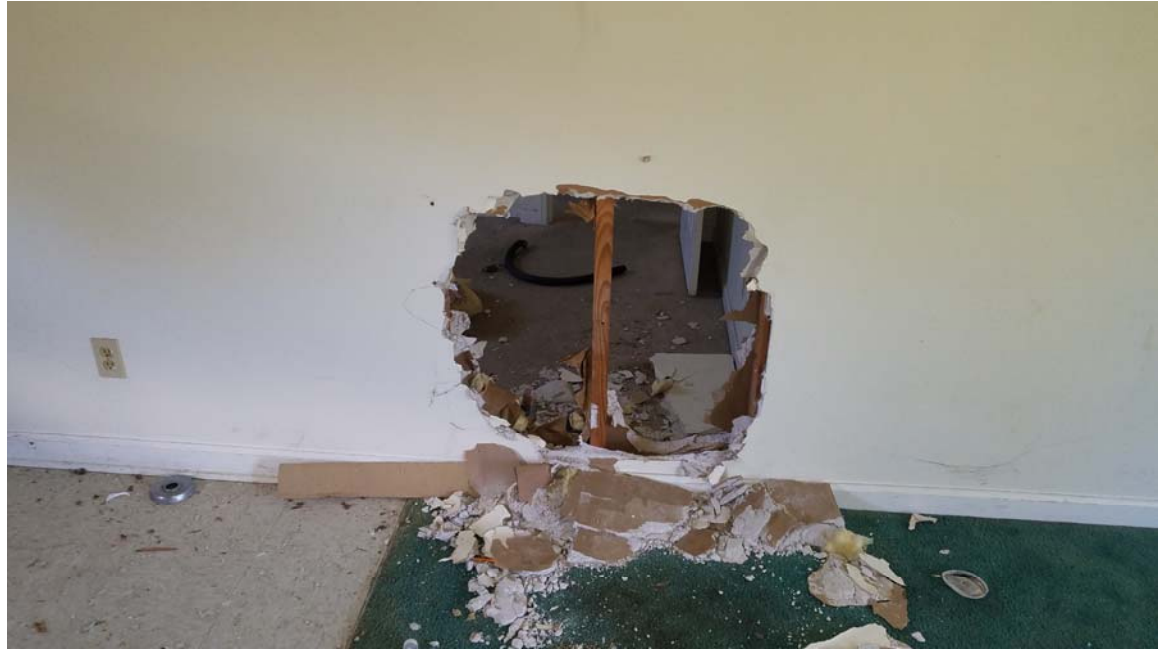
Example of drywall and patch throughout each unit.

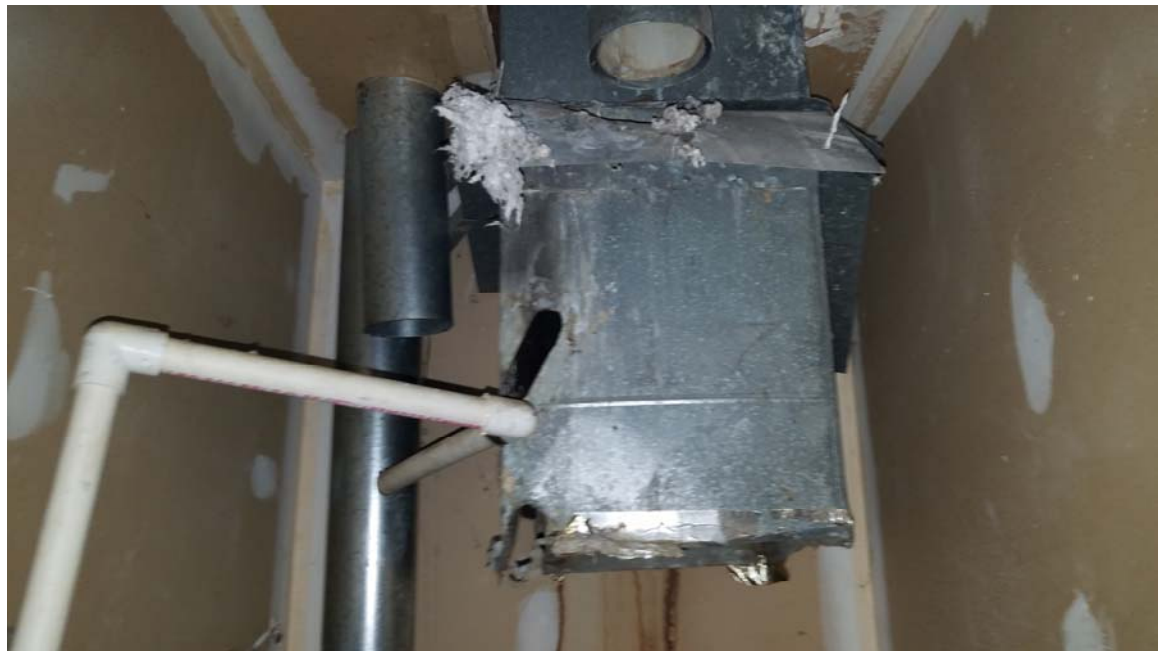
Example of attic insulation throughout each unit.

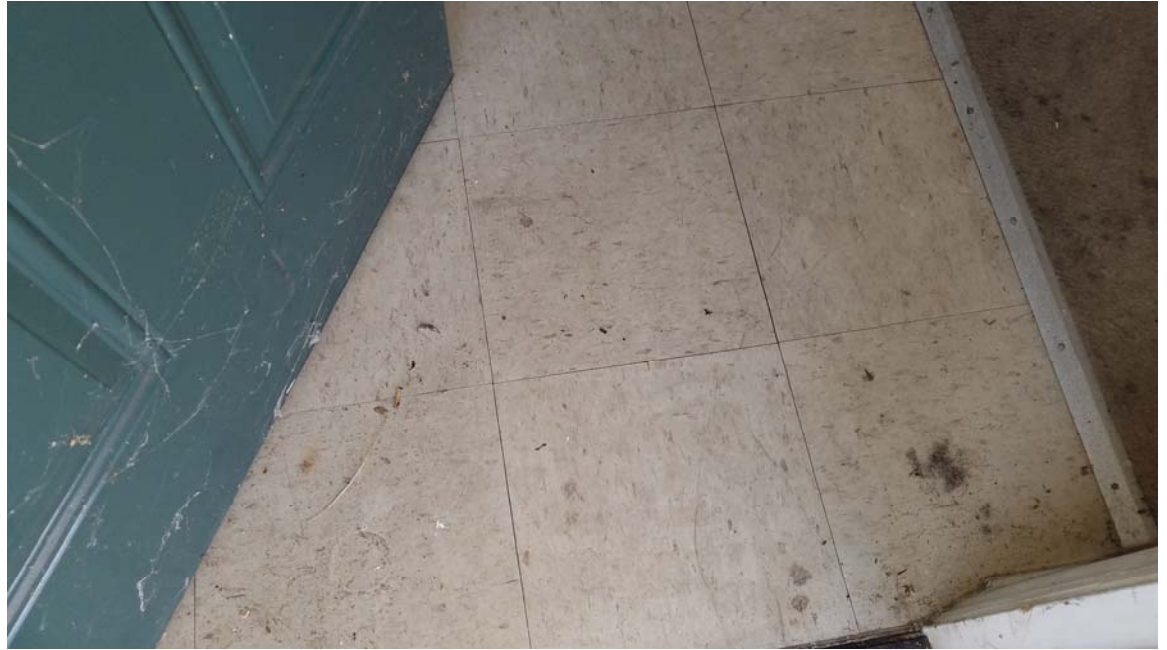
Example of flooring throughout each unit.

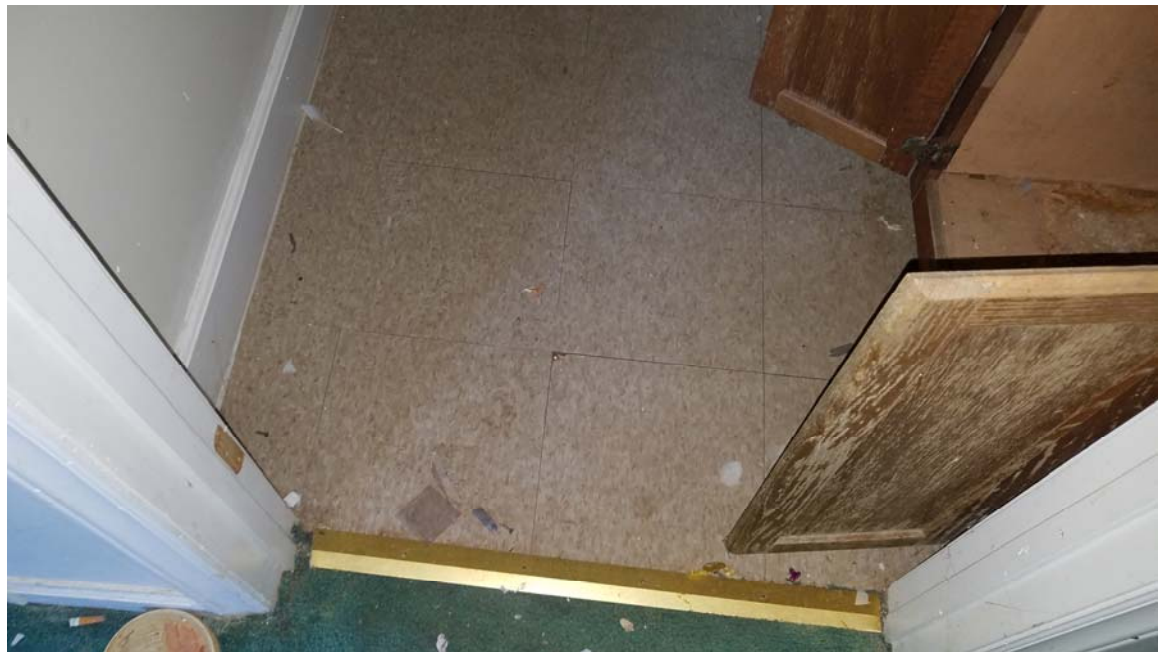
Example of flooring throughout each unit.

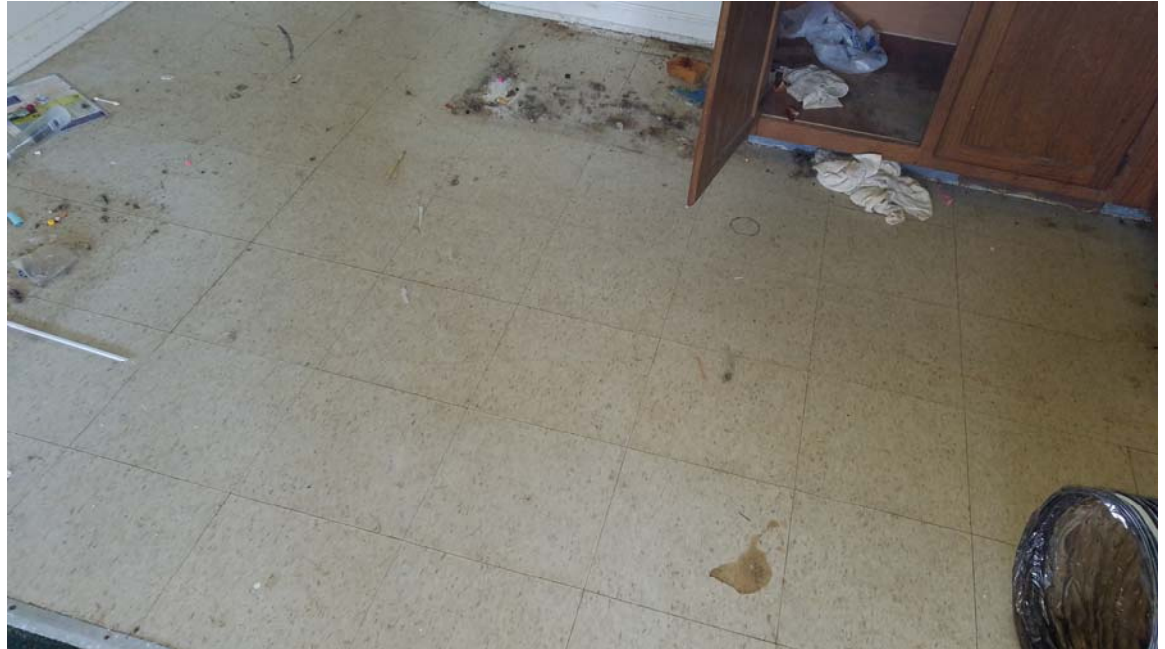
Example of flooring throughout each unit.
