June 2023

Greensboro Aquatic Facilities Master Plan

Greensboro, North Carolina

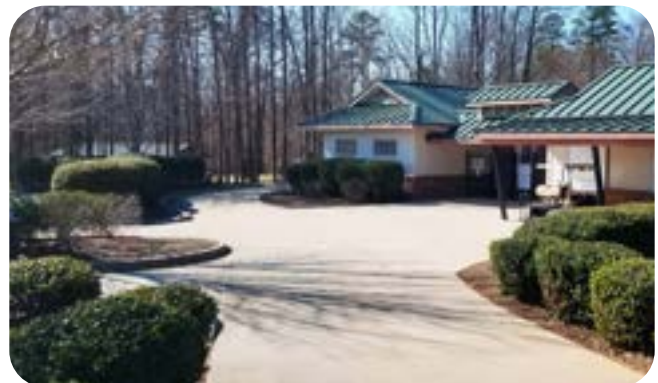
The age of renovations at the park and the variety of amenities and uses lends itself to the condition and upkeep of Barber Park. Generally, the landscaping is well-maintained as are the structures and furnishings. On the splash pad, peeling paint and loose fixtures were observed at the time of the visit.

➤ Entry plaza at Barber Park. Sprayground is beyond the restroom and concession structure in the foreground.

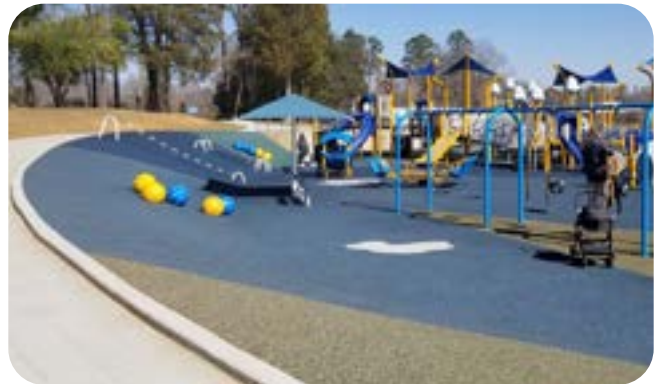
The age of Keeley Park and the variety of amenities and uses lends itself to the condition and upkeep of the site. Generally, the landscaping is well-maintained as are the structures and furnishings. On the splash pad, peeling paint and loose fixtures were observed at the time of the visit. Also, the use of well water has caused rust staining on the surface.

⤴ All-Inclusive playground near sprayground

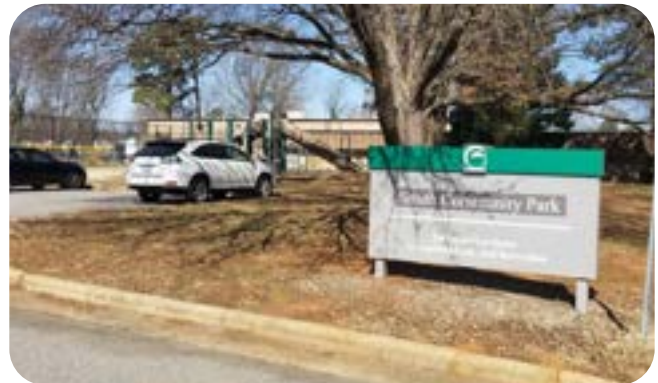
Located within a former mill village, the recreation center does not match or compliment the architectural style of the mill across the street. The landscaping around the building, as well as the parking lot and all amenities seem to undergo routine maintenance, given the clean and manicured look throughout the site.

Main entry signage

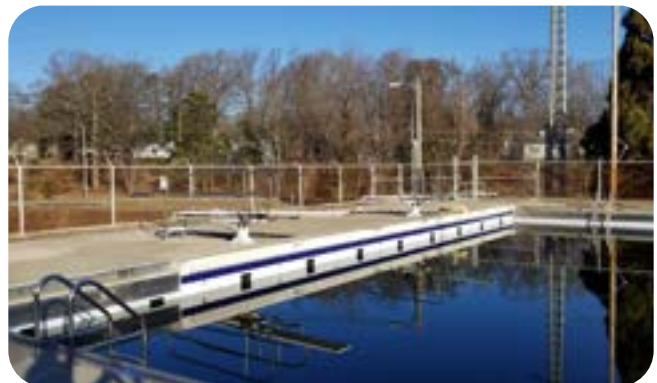
Highway is visible and audibly noticeable from the pool.

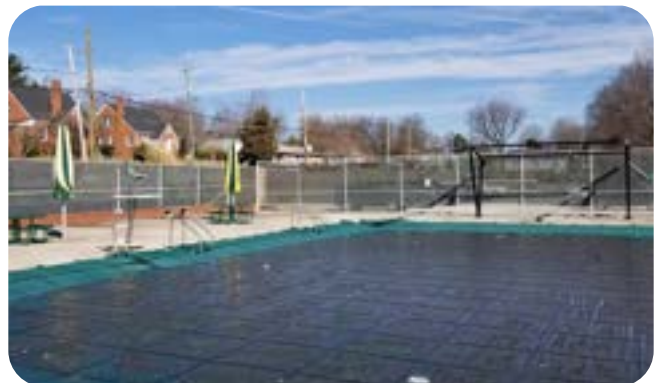
Being amongst the oldest aquatics and recreation facilities in Greensboro, the recreation center and pool are showing various visible signs of degradation. The recreation center facades are unique, creating architectural interest and identity. The pool surface is spalling in various areas and has been patched as needed, creating inconsistency in color and texture.

▲ Pool deck, furnishings, and winterized shade structure

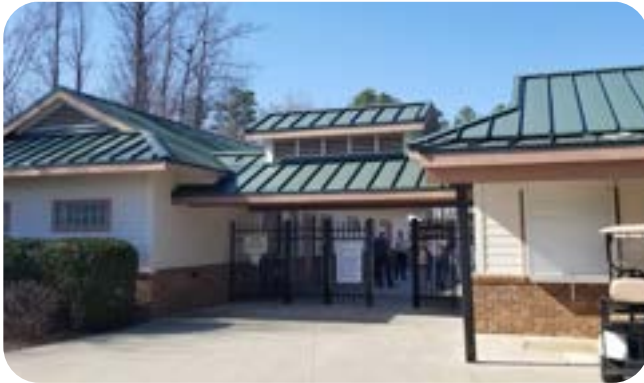
^ Exterior of the building at Barber Park

The building exterior is comprised of fiber cement siding, split face CMU, standing seam metal roof, hollow metal doors, and aluminum gutters and downspouts. The building exterior is in very good condition. Exterior recommendations include:

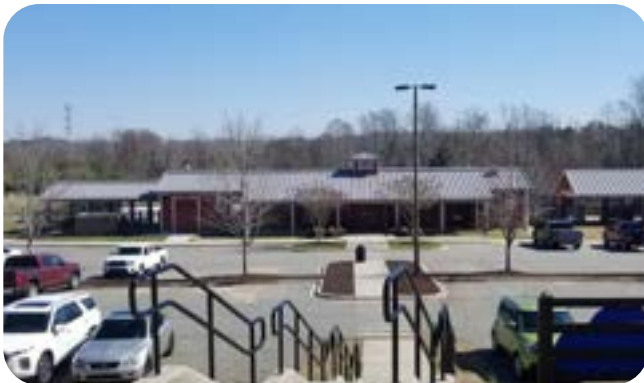
↗ Exterior of the building at Keeley Park

The building exterior is comprised of fiber cement siding, split face CMU, standing seam metal roof, and aluminum gutters and downspouts. The building exterior is in very good condition. No recommendations for exterior repair at this time.

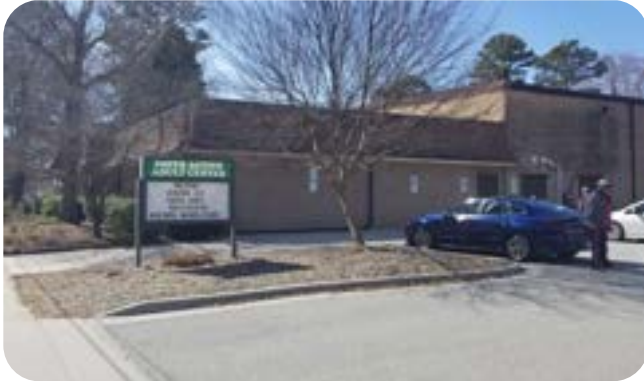
↗ Exterior of Smith Active Adult Center

Smith is an indoor pool facility, and the exterior observation was limited to the area outside the pool equipment room. The exterior wall system in the pool equipment roof area is a masonry veneer over CMU backup. Doors are hollow metal. Exterior recommendations include:

- › The masonry veneer is in good condition but stained from mildew and age. Veneer should be cleaned.
- › Drain piping from the pool equipment room is located above the hollow metal door. The drain has deteriorated the door's drip header beyond repair and the drip should be replaced. The drain line has been turned to drip beside the door and that has deteriorated the sidewalk concrete at the bottom of the wall and will ultimately rust out the hollow metal door frame.

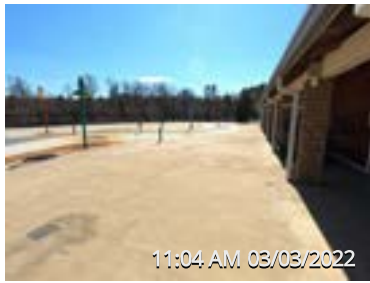
OVERVIEW

Outdoor seasonal spray ground with separate holding tank and pool water filtration system.

Heavy staining is present on the deck and spray features. The source of this staining is likely the source water. Any dissolved metals will cause stains on porous surfaces.

Minor cracks and concrete settling were noted. Suggest consulting with a concrete company for repair options.

There are overlay product options that could be considered.

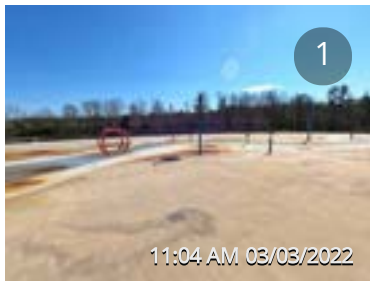
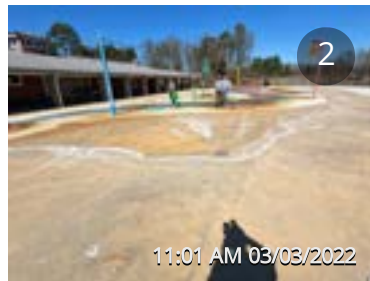
SPRAY GROUND FEATURES

Heavy staining is present on the spray features. The source of this staining is likely the source water. Any dissolved metals will cause stains on porous surfaces.

These features are poured in place and would need to be painted or restored in place.

Hot water high volume low pressure washing and metal sequestering chemicals may help.

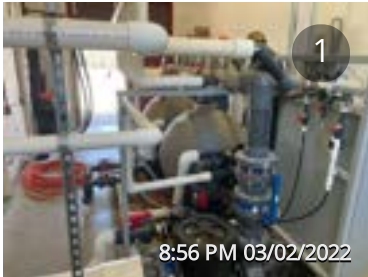
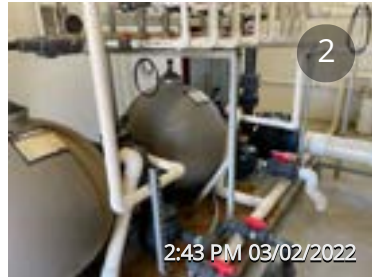
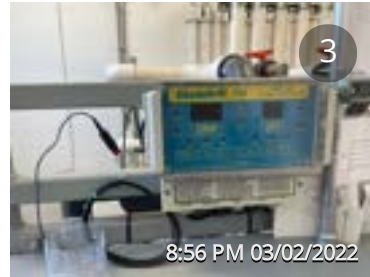
SPRAY GROUND MECHANICAL ROOM - CHEMICAL DELIVERY SYSTEM

Overall the chemical rooms are in fair condition. The original "secondary containment" crocks are not being used as intended. Chemicals are being pumped from barrels into these crocks.

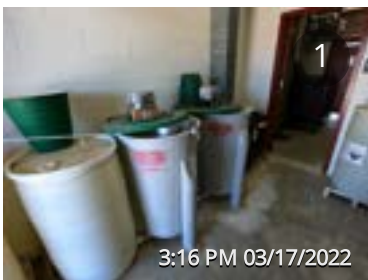
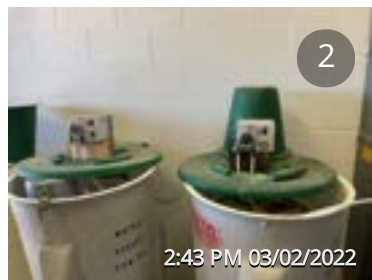
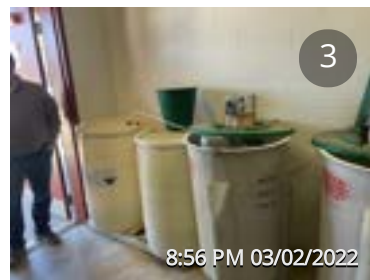
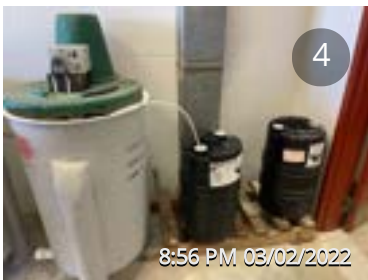
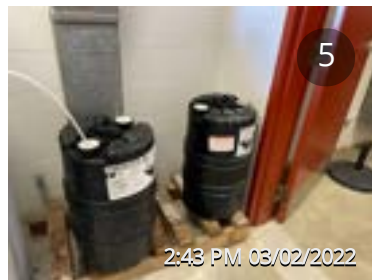
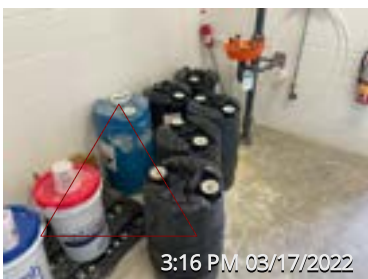
SPRAY GROUND - CHEMICAL SAFETY CONSIDERATION

Overall chemical safety practices should be reviewed.

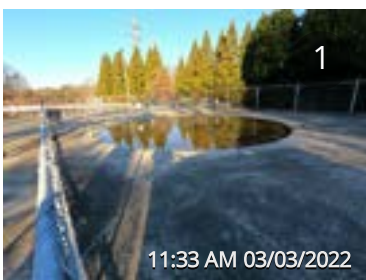
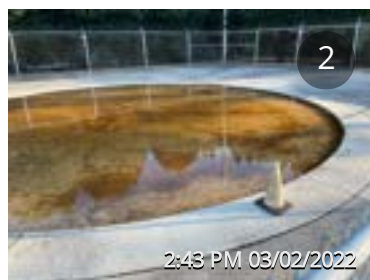
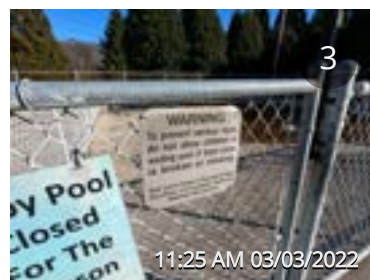
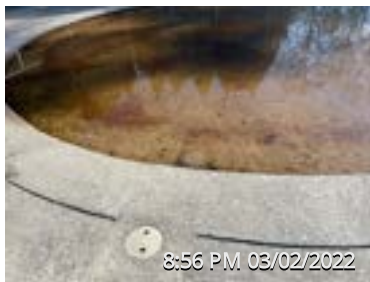
SUBMERGED DRAINS

Lap Pool - not observed. The pool was full at the time of the visit.

Children's Pool - observed from deck level.

The lap pool has a PVC membrane liner. Approximately 3 inches of the liner was observable.

These types of liners have a typical 10-15 year lifespan depending on water quality.

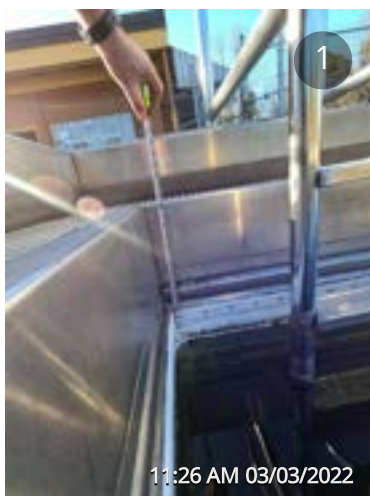
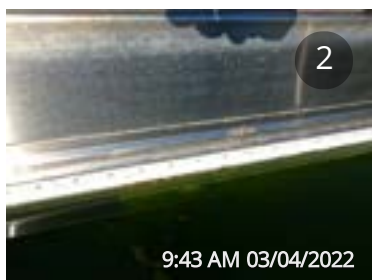
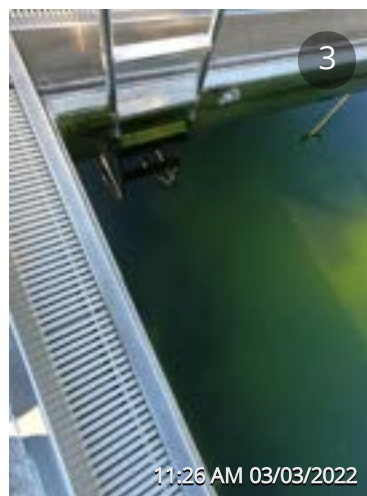
SURFACE GUTTERS AND SKIMMERS AND POOL WATER RETURN

The lap pool has a perimeter stainless steel gutter and water supply system.

The gutter has been replaced for approximately 3/4 of the pool and there is a different gutter style at the deep end near the mechanical room for unknown reasons.

The children's pool has a single skimmer.

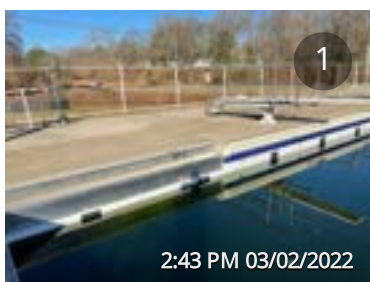
DEPTH MARKERS AND NO DIVING MARKERS

Depth markers and no diving signs were a combination of tiles and paint. Depth markings were noted on the vertical surfaces attached to the fence.

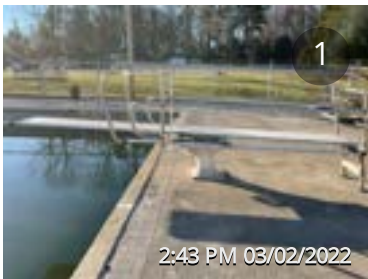
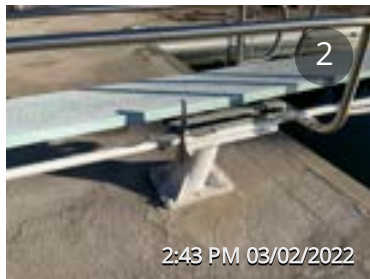
LADDERS, STEPS, AND HANDRAILS

Seven pool ladders were noted as present and secure.

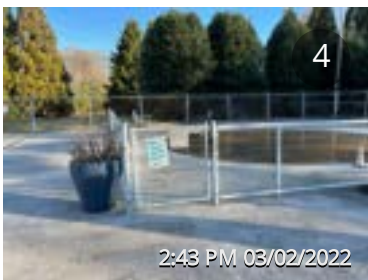
POOL ENCLOSURE

Pool fencing was present but not evaluated.

The self-closing and latching gate for the children's pool was present and operational.

NC Code .2528, .2537

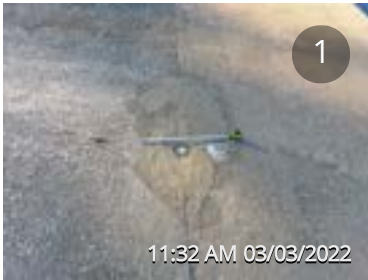
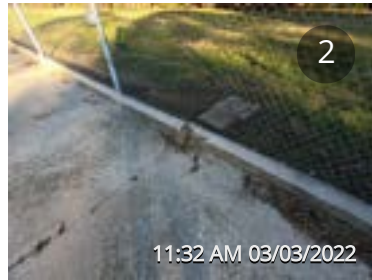
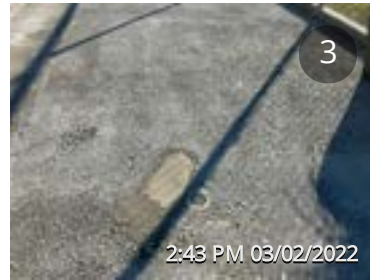
POOL DECKS

Decks were cracked, stained, and missing sections of surfacing.

Areas of prolific deterioration were noted.

NC Code .2522, .2537

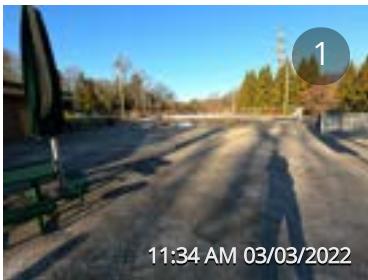
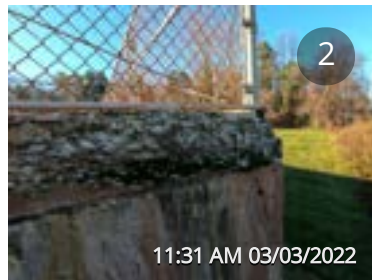
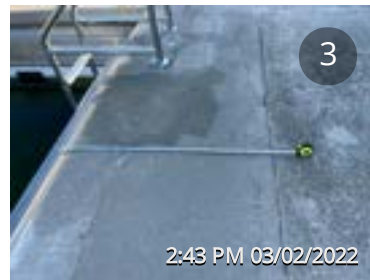
POOL DECKS (CONTINUED)

Decks were cracked, stained, and missing sections of surfacing.

Areas of prolific deterioration were noted.

NC Code .2522, .2537

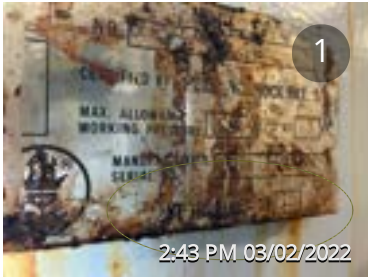
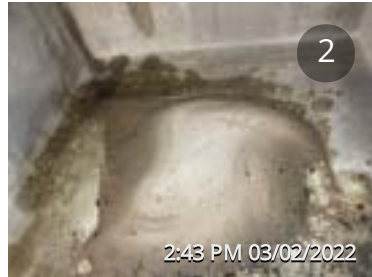
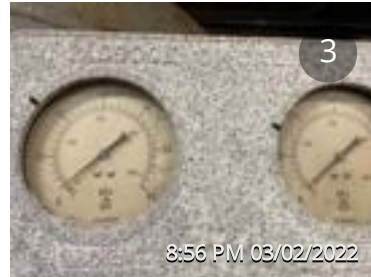
The influent and effluent gauges were present but uncertain if these are working. The filter tanks show evidence of long-term leaks.

The large pile of sand in the backwash separation tank indicates these filters have internal damage.

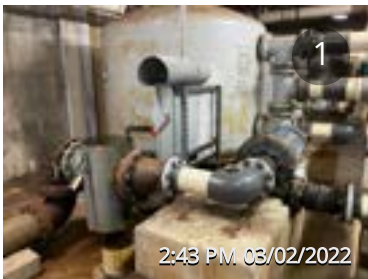
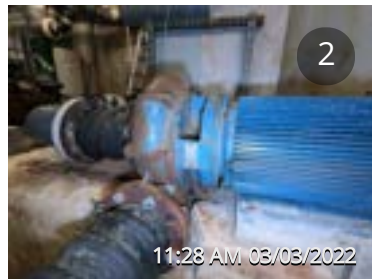
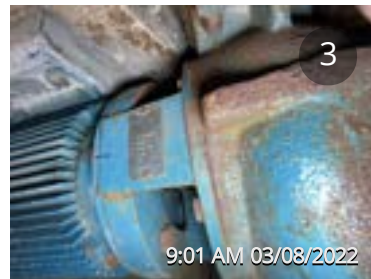
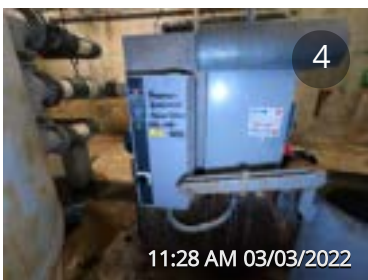
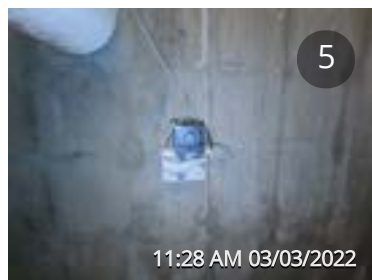
LAP POOL EQUIPMENT ROOM - CIRCULATION SYSTEMS

Single pump and motor.

Filter VFD: Danfoss

Flow Meter: Present

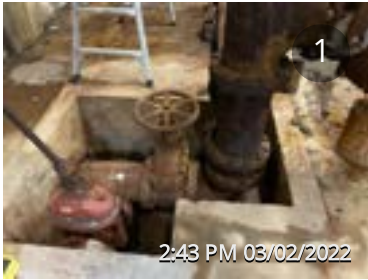
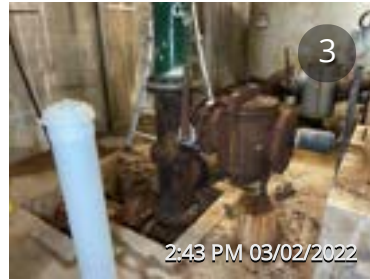
LAP POOL EQUIPMENT ROOM - CIRCULATION SYSTEMS

All metal plumbing, valves, and gears are heavily corroded.

(3) Abandoned valve system and strainer basket for the original pump.

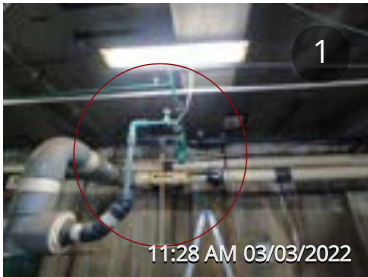
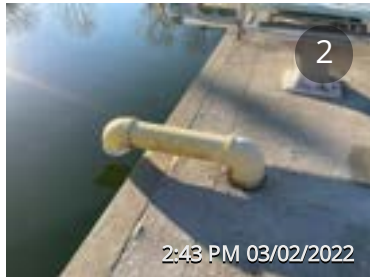
LAP POOL EQUIPMENT ROOM - DOMESTIC WATER FILL

Freshwater fill system. The operational condition is unknown.

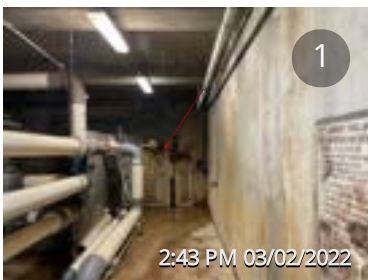
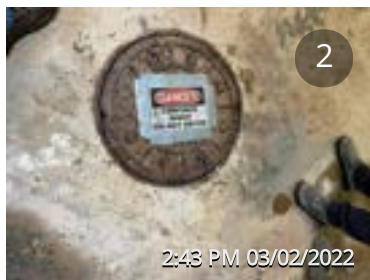
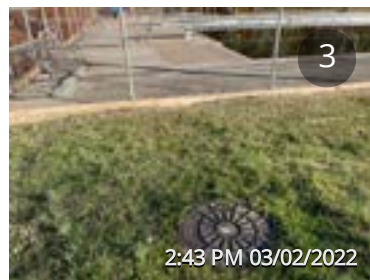
LAP POOL EQUIPMENT ROOM - DOMESTIC WATER FILL

Staff reported that during the operational season large volumes of water will leak into the pumproom from the far wall (1) the source of this water should be explored further.

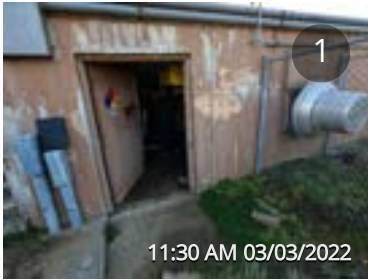
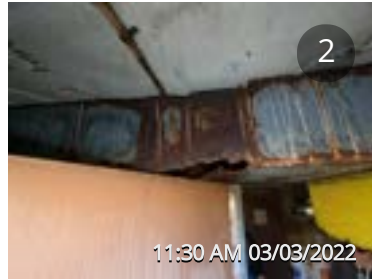
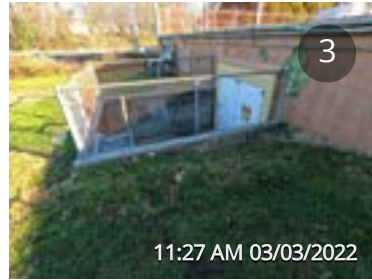
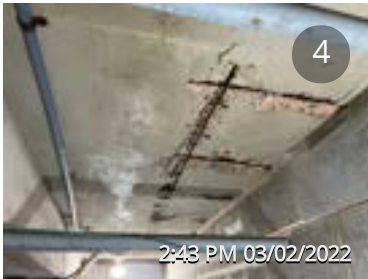
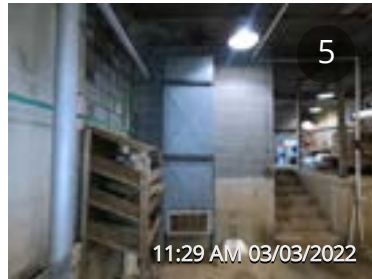
LAP POOL EQUIPMENT ROOM - GENERAL CONDITIONS

The pump room is in need of repairs and upgrades. The ventilation system has been abandoned. The concrete roof has signs of significant deterioration.

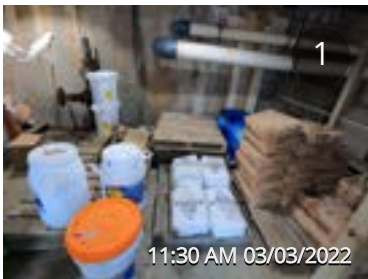
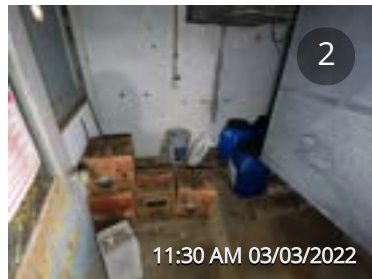
LAP POOL EQUIPMENT ROOM - CHEMICAL STORAGE

NC Code .2533, .2534, .2537

Chemicals should be stored in a dry well-ventilated enclosure.

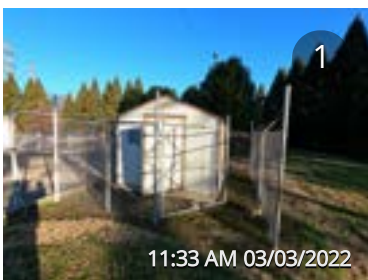
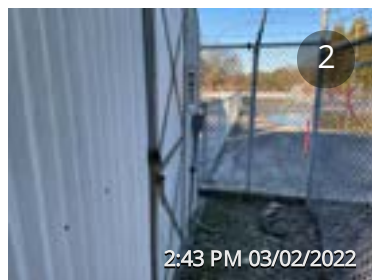
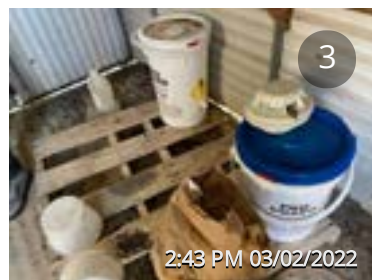
CHILDREN'S POOL - EQUIPMENT ROOM

The equipment room and chemical storage area are located in a shed near the pool.

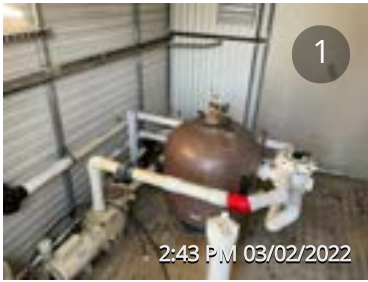
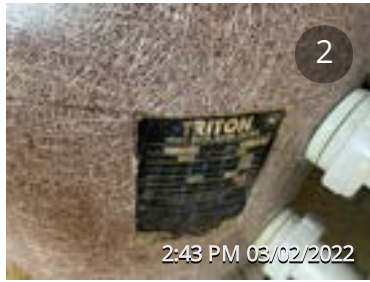
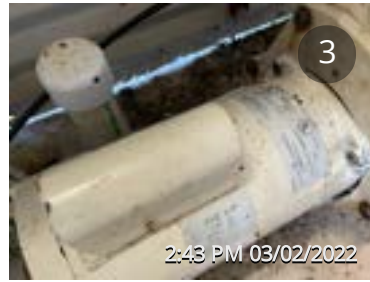
CHILDREN'S POOL - CHEMICAL DELIVERY AND FILTRATION SYSTEM

Single filter system

Minimal labeling of valves and pipes.

Chemical Delivery System: No automated chemical feeder. Erosion-style trichlor chlorine feeder. Manual acid delivery.

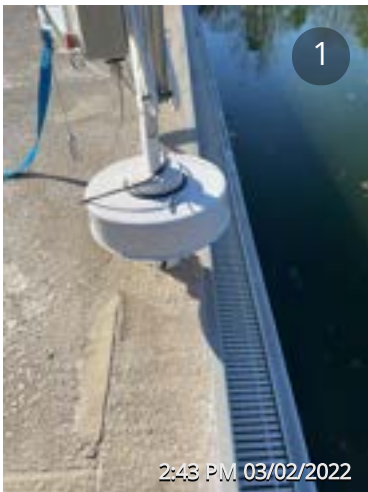
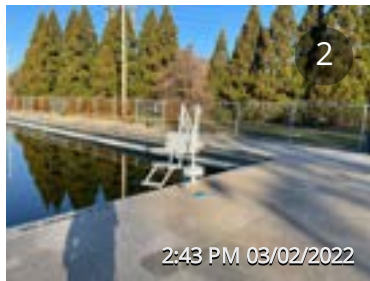
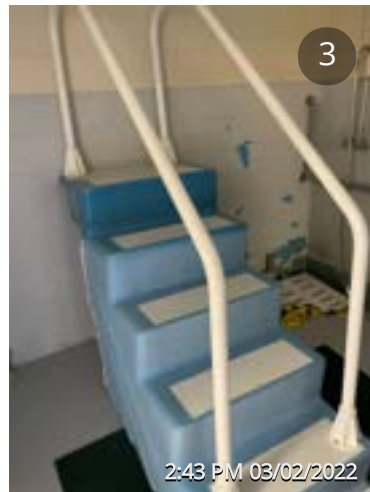
OVERVIEW - PEELER-ANNIE WILLIAMS PARK POOL

25m x 25m L-shaped lap pool. Actual pool volume and data were not provided. The lap pool was covered at the time of this visit. The pool shell evaluation is limited.

The pool has remained unused for some time. Aquatic vegetation was growing on top of the winter cover.

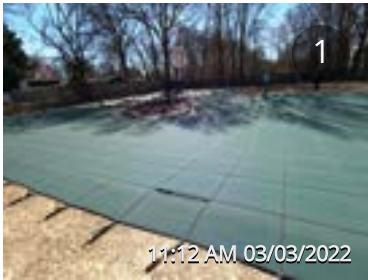
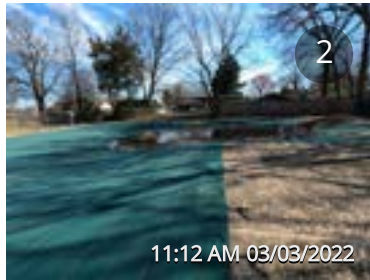
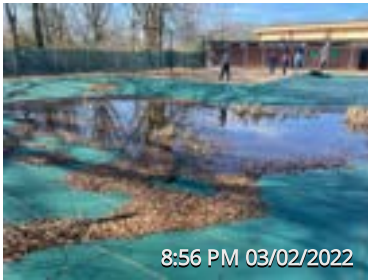
SUBMERGED DRAINS

Not observed - the pool was covered and full at the time of this visit.

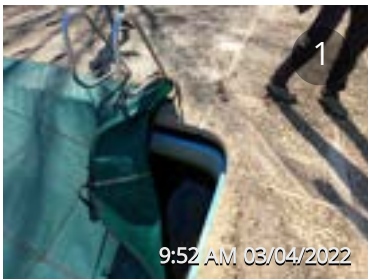
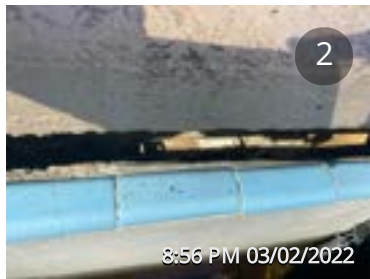
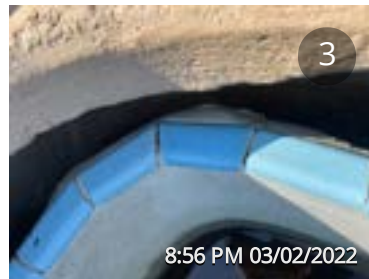
SURFACE GUTTERS AND POOL WATER RETURN

The lap pool has a tile and surge-style gutter system. Limited exposed areas of the plaster finish show signs of cracking and deterioration and appear to be in poor condition.

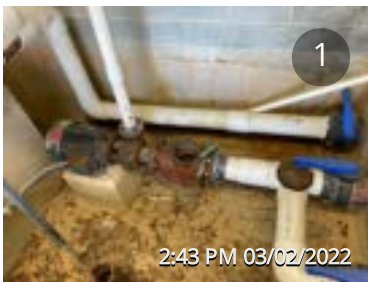
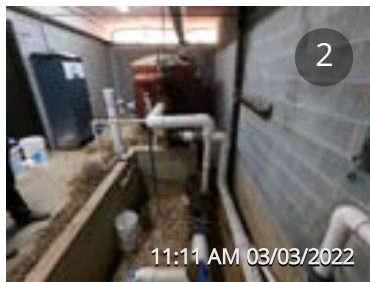
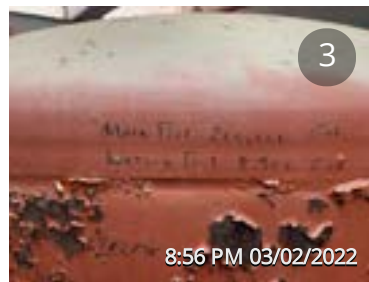
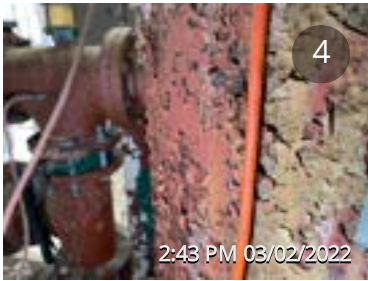
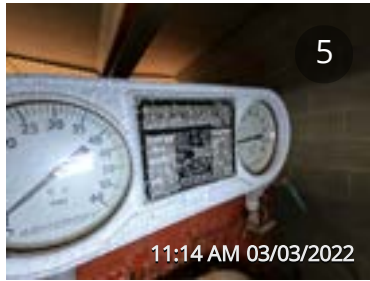
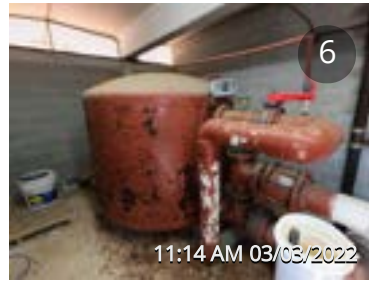
LAP POOL EQUIPMENT ROOM - CHEMICAL DELIVERY

The pool uses an erosion-style trichlor feeder and manual addition of acid for pH control. No automated chemical controllers are present.

Unused chemicals should be stored properly.

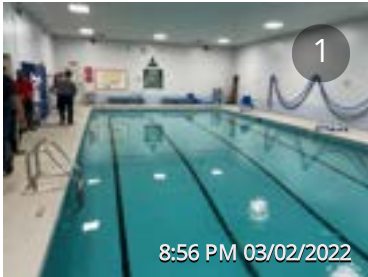
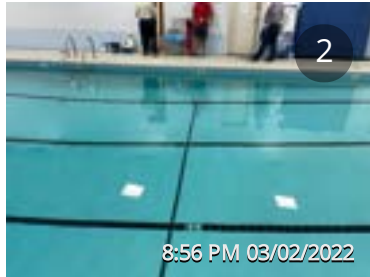
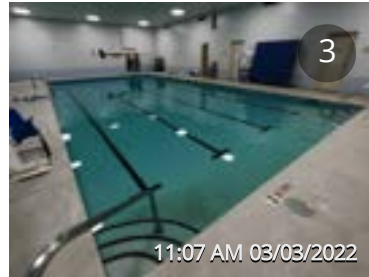
LAP POOL - STAIRS AND MAIN DRAINS

Handrails were tight and the skimmers were in good condition.

Two main drain covers were present and were evaluated from deck level.

The client should ensure that all drains comply with ASME/ANSI A12.19.8-2007 NC Code .2537, .2539

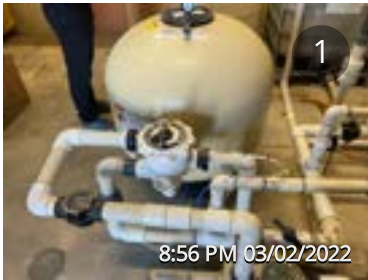
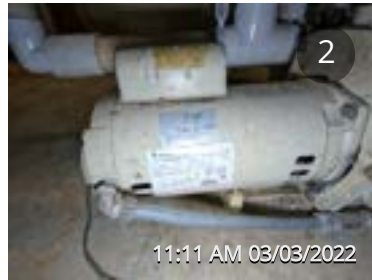
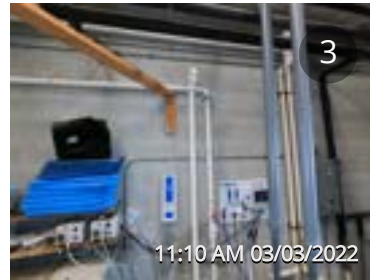
LAP POOL EQUIPMENT ROOM - FILTRATION SYSTEM

The pump room was clean and organized and appeared to be leak-free.

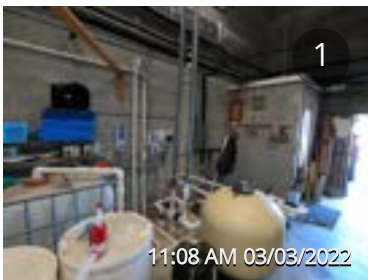
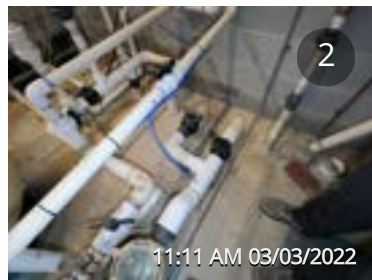
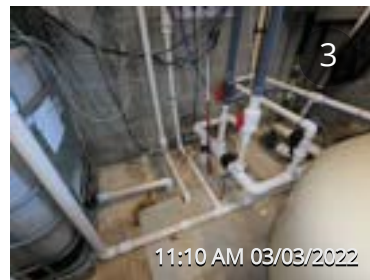
LAP POOL - EQUIPMENT ROOM CHEMICAL DELIVERY SYSTEM

The chemical delivery system was installed and appeared operational.

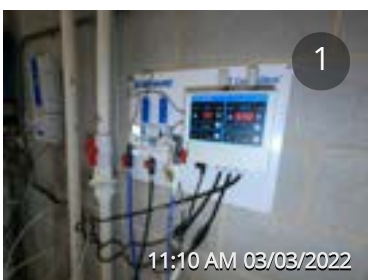
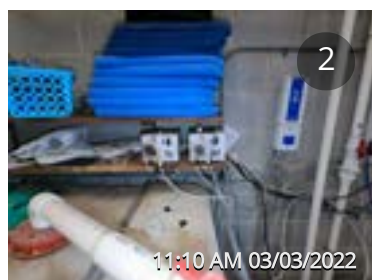
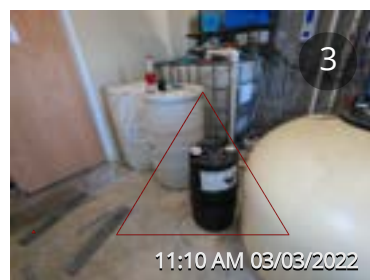
LAP POOL EQUIPMENT ROOM - CHEMICAL STORAGE - SAFETY CONCERN

1-2) Chlorine and acid barrels - open bungs pose a safety concern for staff and patrons.

3) From the original supplied plans, there was a separately ventilated storage room for chlorine gas but that room is now used for various pool chemical storage. Suggest restoring this room to its original designed intent. This room should be used to store chlorine or acid but not both incompatible chemicals.

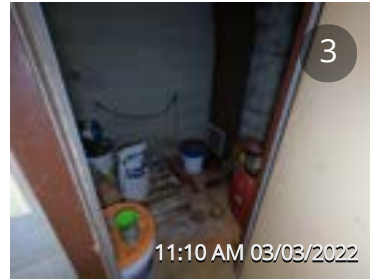
LAP POOL EQUIPMENT ROOM - SAFETY CONCERN

An empty cyanuric acid container was found in a chemical storage area that was hand-labeled "Cal Flake" CDC Chemical Safety Handling: Store chemicals in original, manufacturer's-labeled containers.

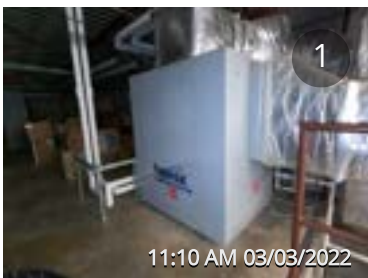
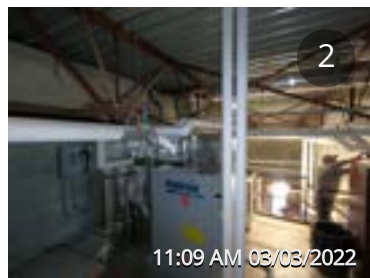
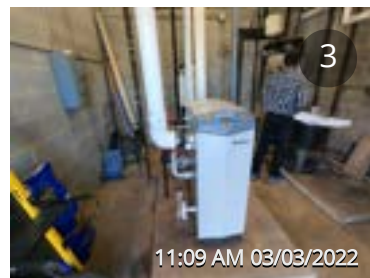
LAP POOL EQUIPMENT ROOM - HEATING AND VENTILATION SYSTEM

Pool exhaust system for reference. This system was not evaluated.

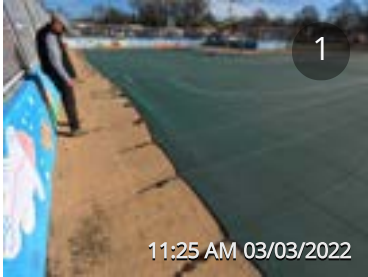
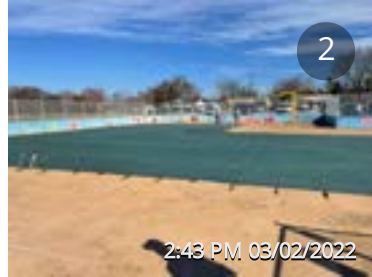
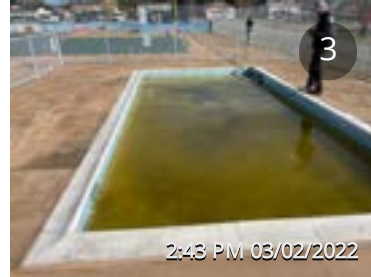
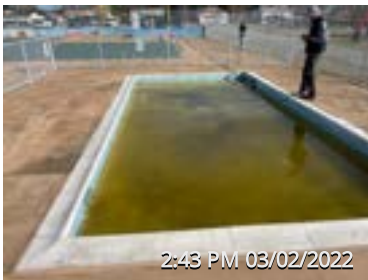
SUBMERGED DRAINS

Lap Pool - not observed. The pool was full and covered at the time of the visit.

LAP POOL - GUTTER SYSTEM

Tile gutter system. Limited exposed areas show signs of cracking and deterioration.

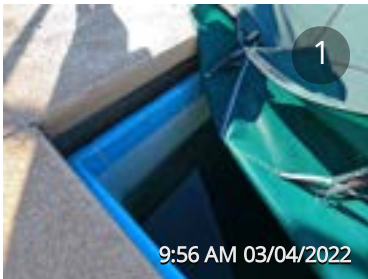
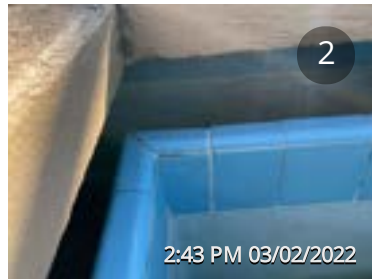
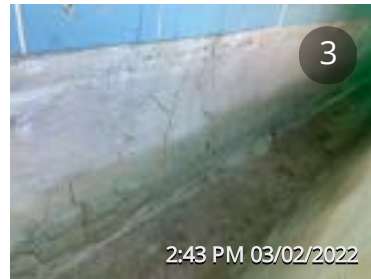
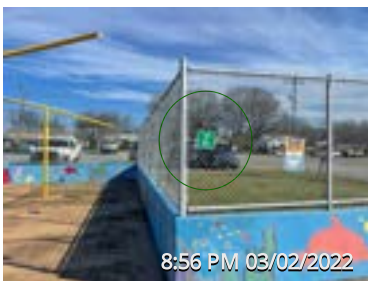
DEPTH MARKERS AND NO DIVING MARKERS

The deck-mounted depth markers could not be observed because they were covered by the winter cover. Limited vertical markers were noted attached to the pool fence.

The observable handrails appear to be in good condition.

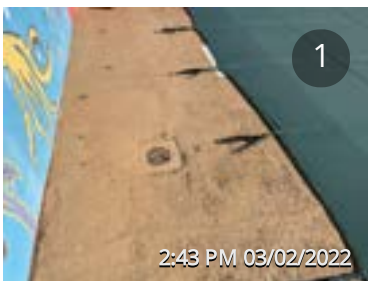
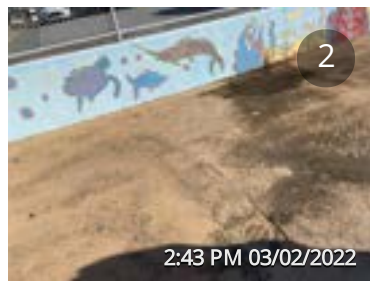
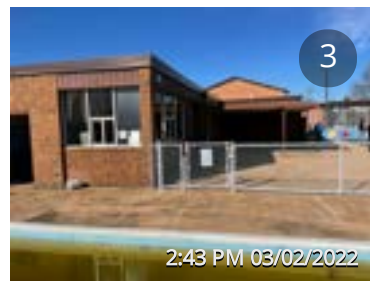
CHILDREN'S POOL DECK

Decks were cracked, stained, and missing sections of surfacing.

Areas of prolific deterioration were noted.

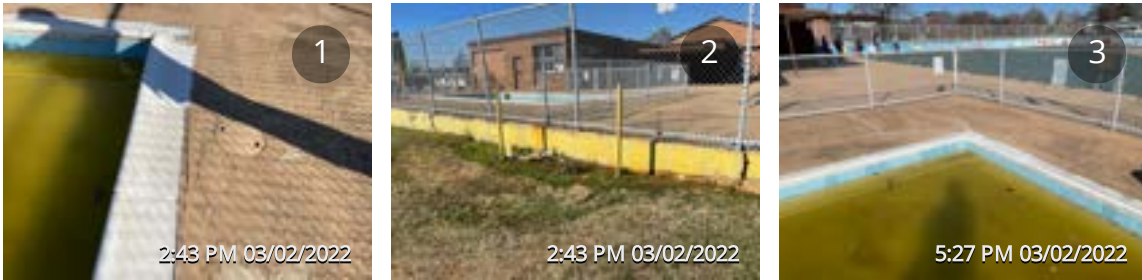
CHILDREN'S POOL DECK (CONTINUED)

Decks were cracked, stained, and missing sections of surfacing.

Areas of prolific deterioration were noted.

Significant cracking, signs of settling, and a large hole were noted under the deck in the South East Corner of the facility.

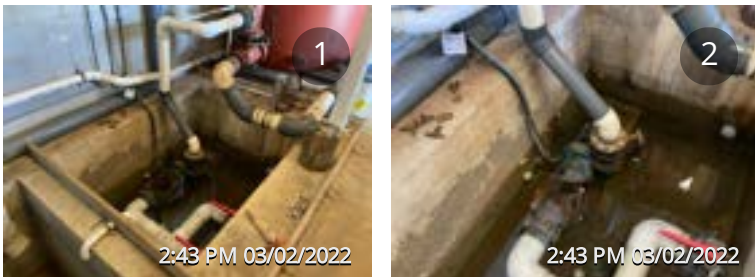
LAP POOL EQUIPMENT ROOM - FILTRATION PUMP

The lap pool pump pit was flooded at the time of this visit and could not be safely evaluated. The motor was underwater and will need to be replaced or repaired before this system can be brought online.

Replaster childrens pool?	b	This could be a lower priority following draining and cleaning
Address deck surfacing/safety	a,b	Patch and/or replace with similar product
New Pump (it was under water)	b	Replace with new/similar pump
Replace/relocate electrical panel	a,b,c	See report
Address stated chemical storage concerns	a	See report
Confirm VGBA Pool and Spa Safety Act Compliance	a,c	Federal Law - safety of suction outlets to limit possibility of entrapment
Windsor Pool		
Add a chemical controller	a,c	Maintains precise level of sanitizer and proper pH
Add automatic chemical feeders (chlorine and acid)	a,c	Chemical are fed automatically ensuring proper sanitizer levels and pH
Address deck surfacing/safety	a,b	Patch and/or replace with similar product
Confirm VGBA Pool and Spa Safety Act Compliance	a,c	Federal Law - safety of suction outlets to limit possibility of entrapment
Secure lid of access tunnel	a	See report

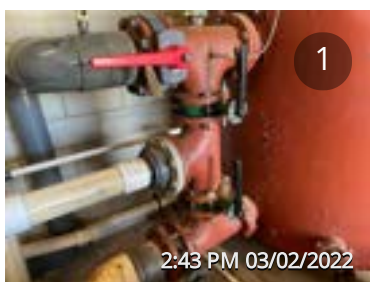
POOL EQUIPMENT ROOM - LAP FILTRATION SYSTEM

The lap pool uses a single high rate sand filter. Evidence of tank leaking was present. Valves had minimal labeling. The data plate was missing.

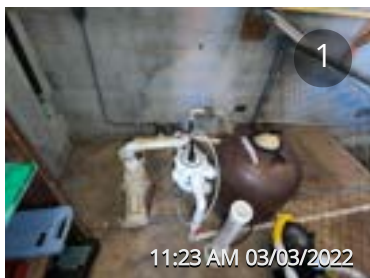
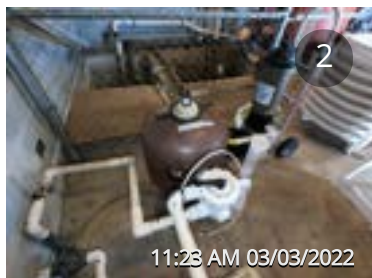
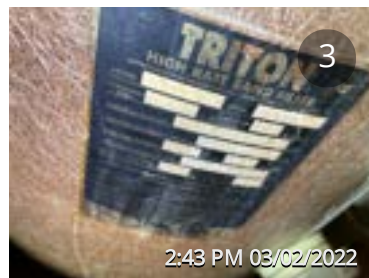
POOL EQUIPMENT ROOM - CHEMICAL SYSTEMS

Both pools use erosion-style trichlor feeders. Manual feeding of acid for pH control. No automated chemical controllers were present.

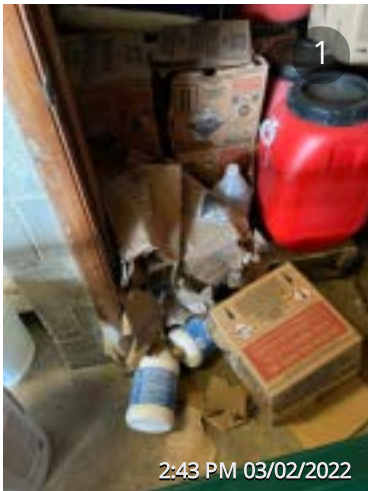
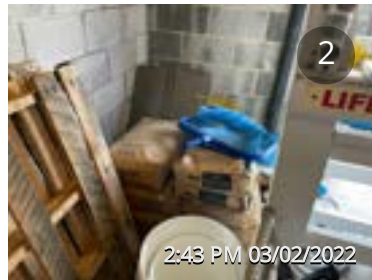
POOL EQUIPMENT ROOM - CHEMICAL STORAGE - SAFETY CONCERN

The potential for a chemical spill emergency was present. Even during the off-season, all pool chemicals should be stored properly.

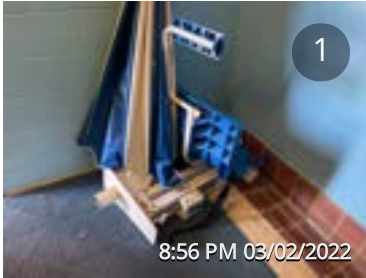
ADA ACCESS

With over 300 linear feet of the perimeter, the lap pool requires a primary and secondary means of access. This requirement is met by one ADA lift chair and a set of removable ADA stairs. Both were observed but not installed.

With less than 300 linear feet of the perimeter, the children's pool requires a primary means of access. There are no ADA accommodations present and a sloped entry would not be readily achievable.

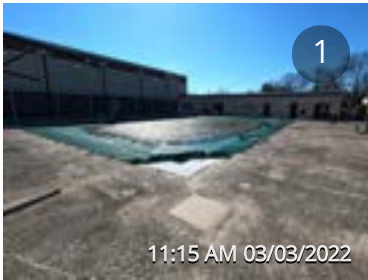
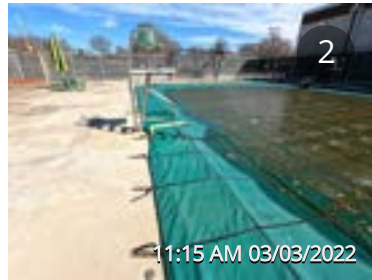
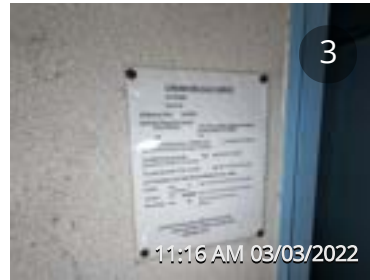
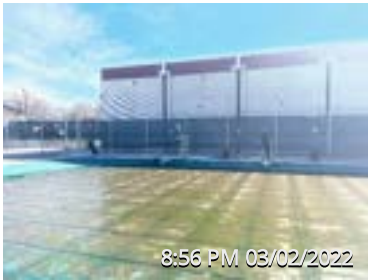
OVERVIEW - WINDSOR COMMUNITY RECREATION CENTER POOL

Facts: 25m rectangular outdoor seasonal lap pool.

Pool volume: 100,000 gallons. The lap pool was covered at the time of this visit. The pool shell evaluation is limited.

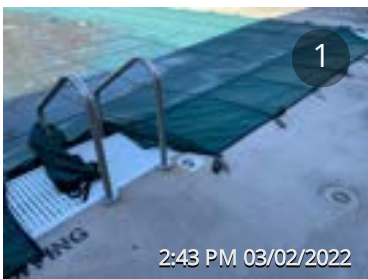
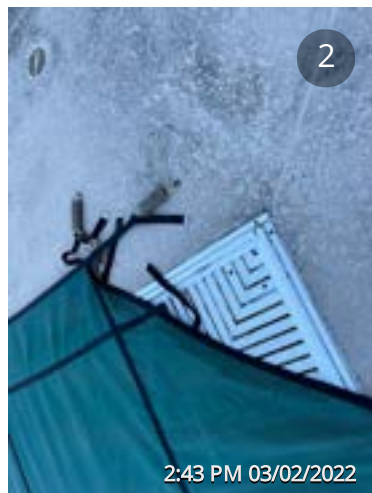
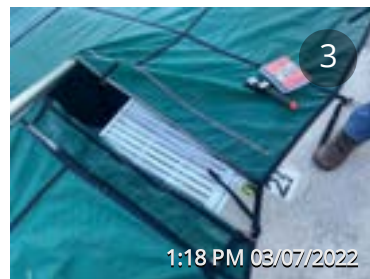
SURFACE GUTTERS AND POOL WATER RETURN

The lap pool has a perimeter gutter system. Overall evaluation of this system was limited due to the pool being covered.

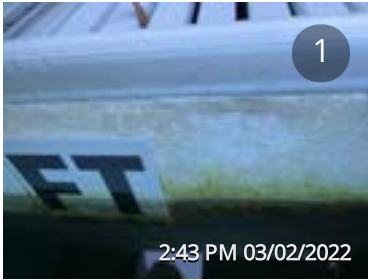
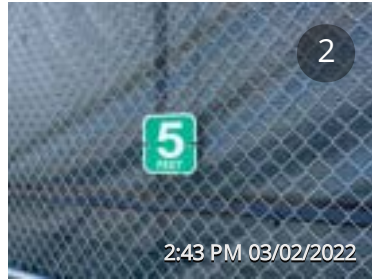
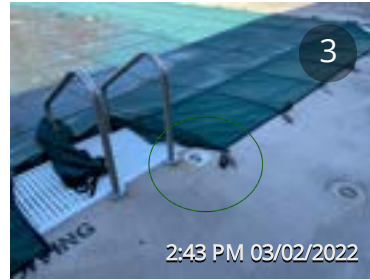
DEPTH MARKERS AND NO DIVING MARKERS

Limited inspection of deck-mounted depth markers because of the pool cover. Vertical markers were noted on the pool fence and on the pool shell.

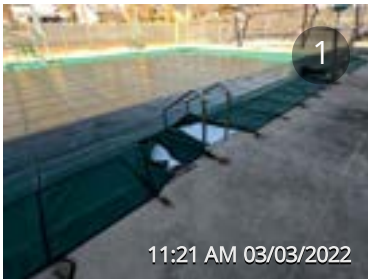
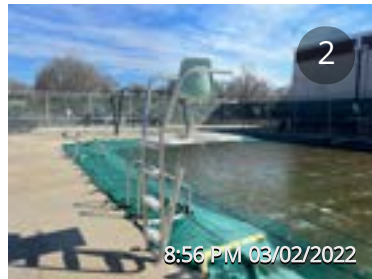
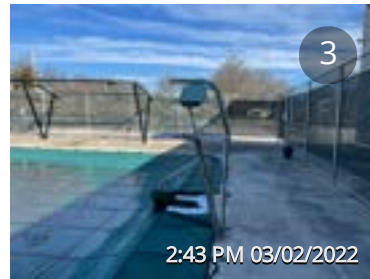
LADDERS, HANDRAILS, LIFEGUARD CHAIR

The observed systems appeared to be in good condition.

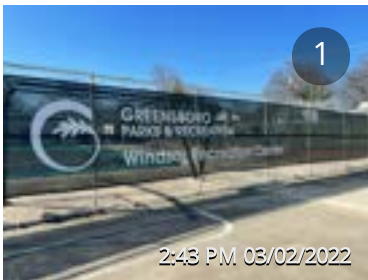
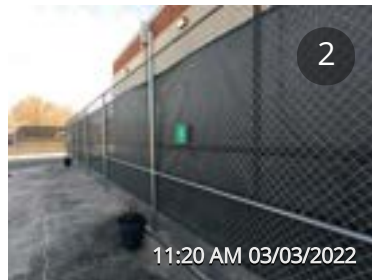
POOL ENCLOSURE

Pool fencing was present but not evaluated.

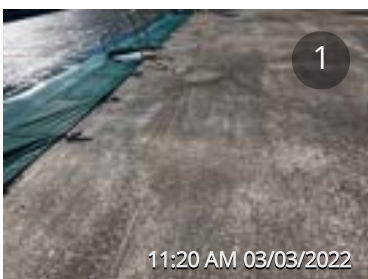
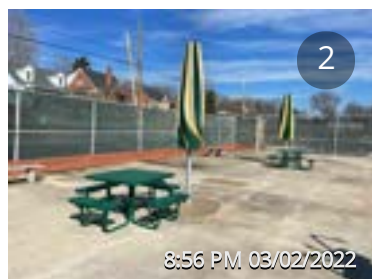
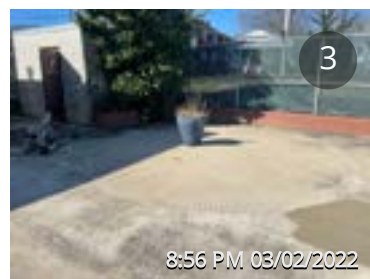
POOL DECKS

The deck was stained and had areas of missing surfacing. Areas of deterioration were noted.

NC Code .2522, .2537

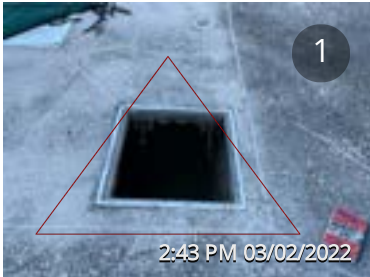
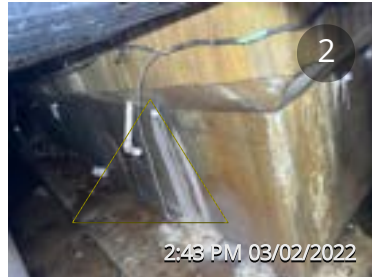
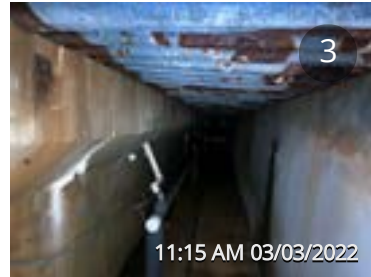
POOL DECK - TUNNEL

A service tunnel is located around the pool structure. Limited inspection of this tunnel discovered possible cut plumbing for pool supply or return. Evidence of pool shell leaks is present.

Safety Concern - the access lid to this tunnel was not secured and was opened without tools. This opening is on a walking path and should be secured.

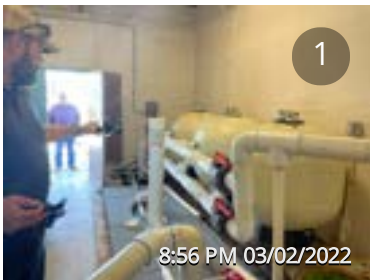
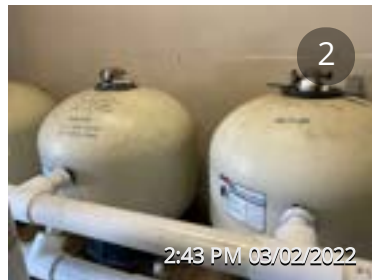
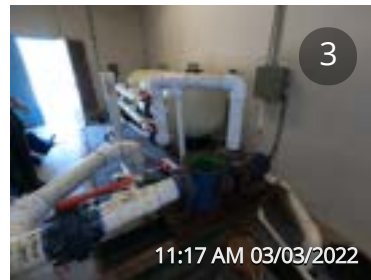
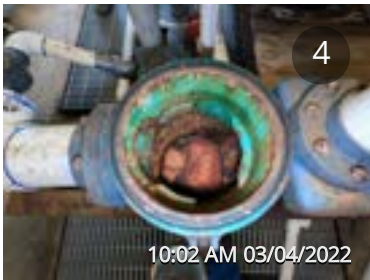
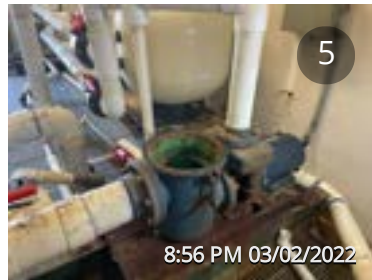
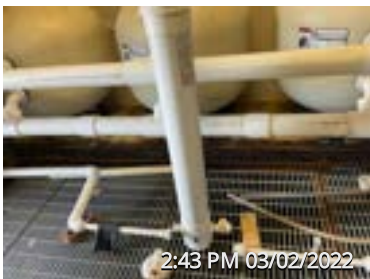
LAP POOL EQUIPMENT ROOM - FILTRATION SYSTEMS

The pool has a single circulation pump and three high rate sand filters. Pump data plates were unreadable.

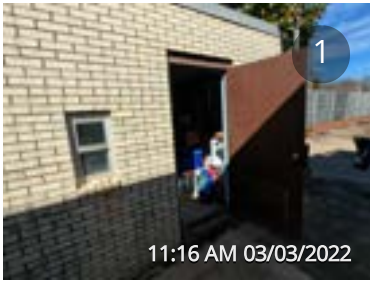
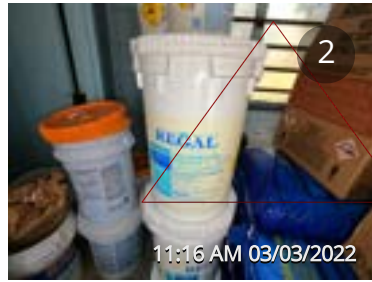
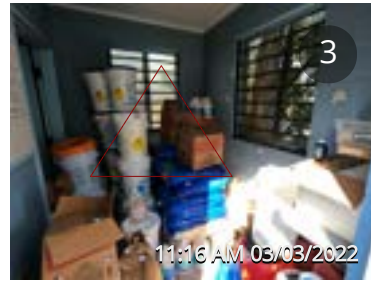
POOL EQUIPMENT ROOM - CHEMICAL STORAGE - SAFETY CONCERN

The pool uses a single erosion-style trichlor feeder and manual addition of acid for pH control. No automated chemical controllers were present.

The potential for a chemical spill emergency was present. Incompatible chemicals (chlorine and acid) are stored in close proximity. Liquid chemicals should NEVER be stored above dry chemicals. Even during the off-season, all pool chemicals should be stored properly.

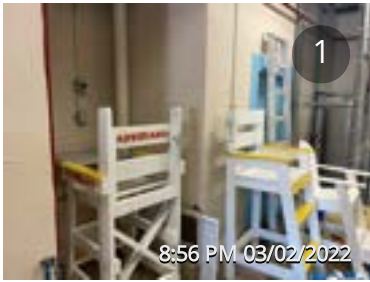
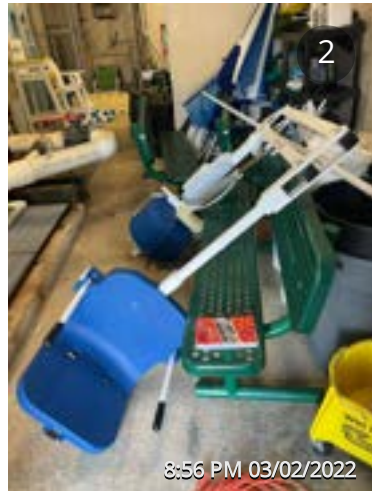
ADA AND RESCUE EQUIPMENT

With over 300 linear feet of the perimeter, the lap pool requires a primary and secondary means of access. One ADA lift chair was observed but not installed at the time of this visit.

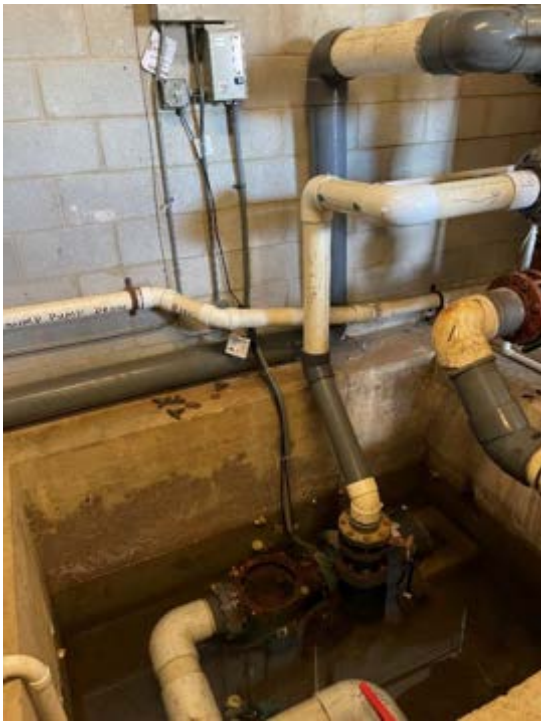
Figure E22 – Pit in Front of Panel and Controls
